Applies to aircraft model Saab 91B och 91C, Safir, serial Nos. 91.201 - 91.289.

*Wing Flap Control.*

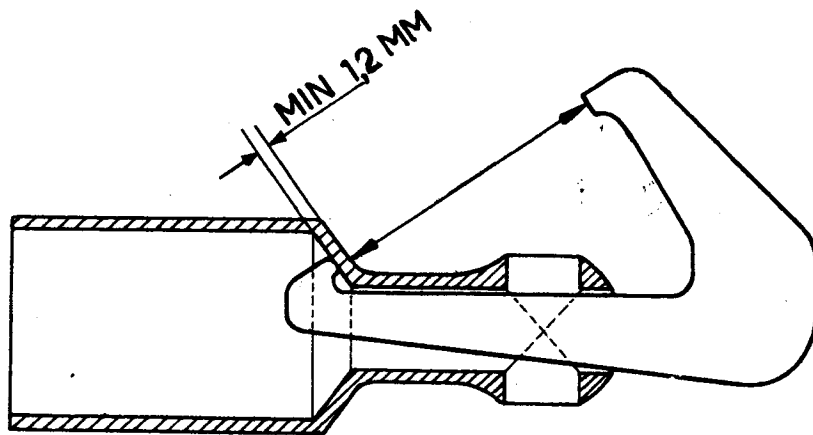
In some cases it has been revealed that the thickness of material of the journal pin 506578 on the torsion tube of the wing flap has been less than the minimum tolerance. For this reason all journal pins shall be checked as to material thickness, as shown in the figure below. If journal pins with a material thickness less than 1.2 mm is found the pin shall be replaced. This inspection shall be carried out in accordance with the manufacturer's Modification Bulletin No. 91 4/4, dated November 10, 1954.
