MODIFICATION BULLETIN

AIRPL
MODEL
91B

91.1/11

Engine cowling. Introduction of reinforcement and locating pins.

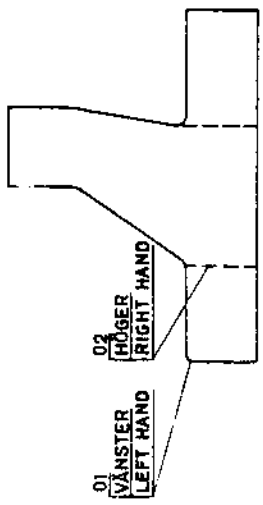
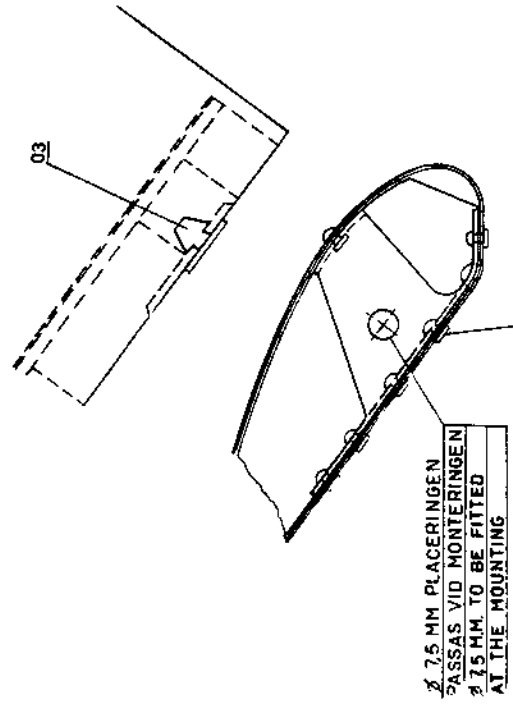
FIG 1

Since cracks has appeared in the upper panels of the engine cowling a reinforcement sheet and a protecting button should be introduced in the upper forward section of the left hand and right hand panel.

UNGEFÄRLIG UTBREDNING
APPROXIMATE SHAPE OF THE SHEET

Make and fit the reinforcement sheets item 01 and 02 according figure 1. Notice that the right hand sheet is smaller than the left hand one. Rivet the reinforcement sheets. Drill holes for and introduce the protecting buttons.

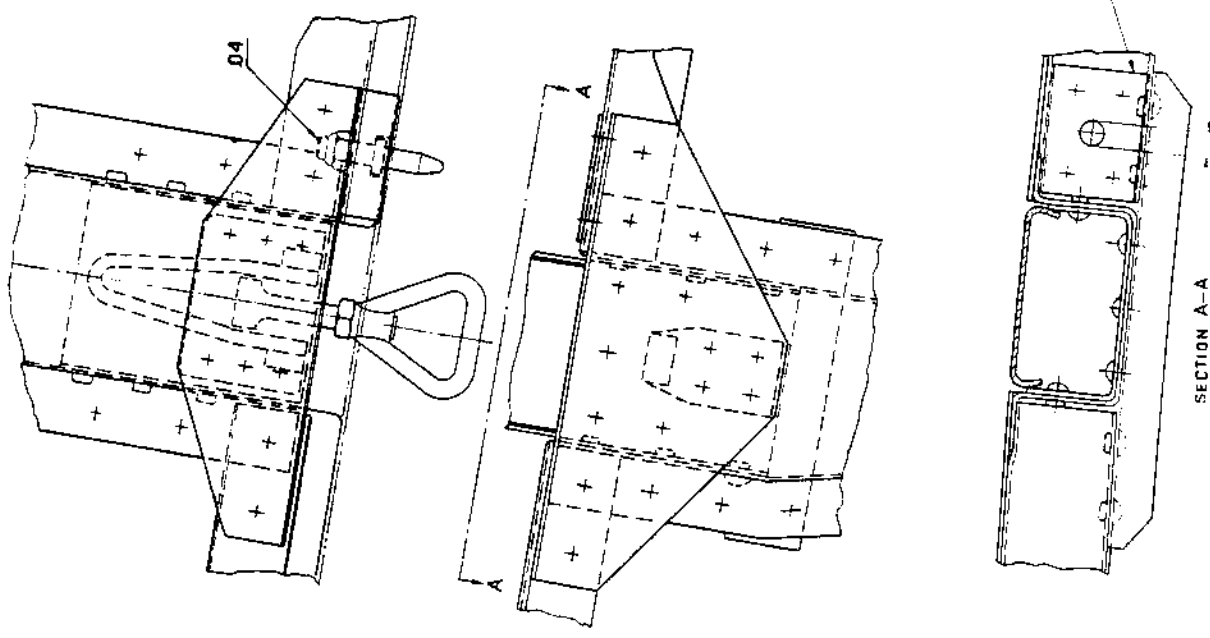
FIG 2

At the same time the forward locating pin should be removed and the locating pin 1077146 should be introduced in the screwhole behind the forward lock, in which case a sheet is added and a hole is drilled in the lower panel.

Remove the screw in the bakelite block behind the forward lock. Fit the locating pin item 04 and rivet sheet item 05 according figure 2. Mount the engine cowling and mark the position of the locating pin. Remove the upper panels and drill ϕ 8 in the lower panel for the locating pin.
