# Modification Bulletin

Reference <b>Airplane 91A, 91B, 91B-2, 91C and 91D Nose wheel casing</b>	Date <b>November 23, 1959</b>	No. <b>91.1/16</b>						
	Saab Service Dept. <b>C Larsson</b>							
Urgency <b>IV</b>	Saab Design. Dept. <b>J Boklund</b>	Royal Swedish Board of Civil Aviation <b>S Fogelström</b>						
	Marking <b>-</b>		Effect on weight distribution					
		<table border="1"> <tr> <th>Weight change Lbs</th> <th>Station In.</th> <th>Moment change Lbsin.</th> </tr> <tr> <td>-</td> <td>-</td> <td>-</td> </tr> </table>	Weight change Lbs	Station In.	Moment change Lbsin.	-	-	-
Weight change Lbs	Station In.	Moment change Lbsin.						
-	-	-

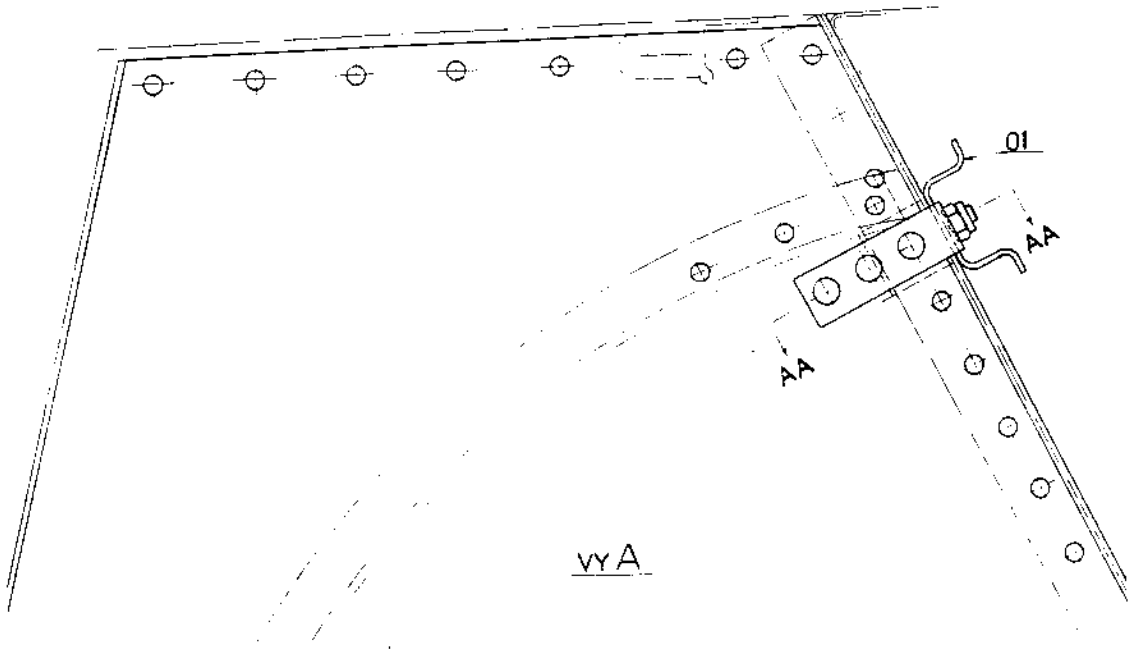
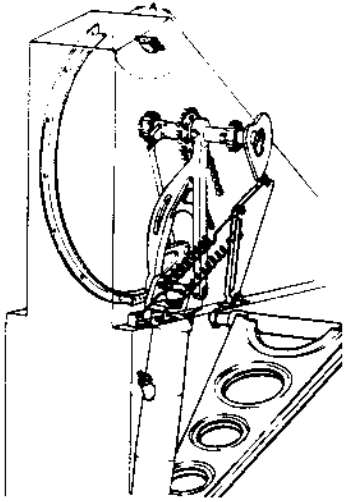
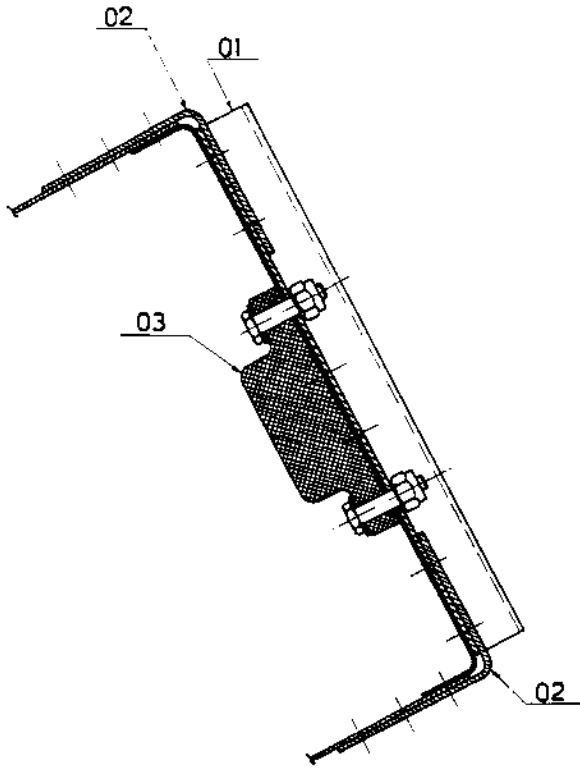
In case cracks have arised in the profile to which the rubber bumper for the nose gear is fixed, the profile can be replaced and 2 brackets introduced.

Loosen the engine instrument panel.  
 Remove bumper 03 according to figure.  
 Drill out the rivets in the profile.  
 Drill holes in the new profile item 01 and brackets item 02 after existing holes in the nose gear casing. Rivet the profiles and the brackets by KN 3,2 AS 211501 acc. to figure.  
 Fit bumper item 03.  
 Fit engine instrument panel.
