MODIFICATION BULLETIN

AIRPL
MODEL
91

Safir

Fuselage. Application of sealings against carbon monoxide

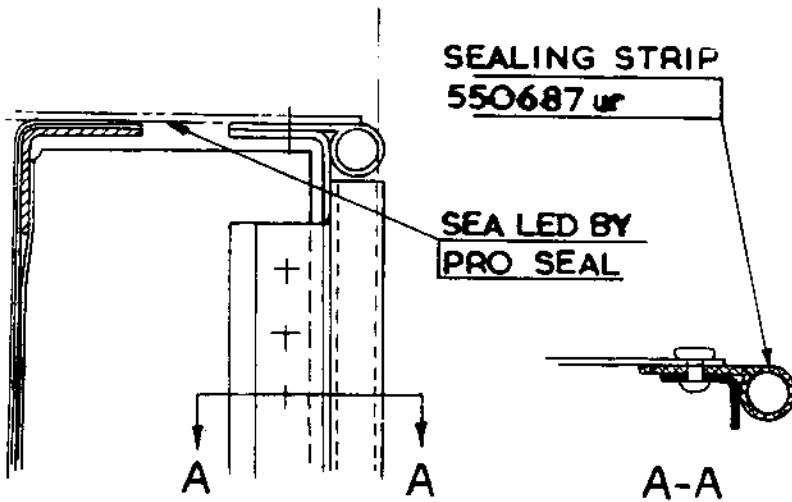
FIG. 1

Carbon monoxide may penetrate into the cabin in certain attitudes of flight. Since the percentage of carbon monoxide in a few cases has been too high, sealing should be applied over tool holes and passages in the fuselage in accordance with the items below, which refer to fig. 4.

9. The passages for stringer and railing in frame 3800 on the right side above the floor and above the luggage rack should be sealed with Pro-Seal.
10. The corners of the luggage rack should be sealed with Pro-Seal.
11. The upper flange of the rear spar should be sealed at the passage through the covering on the right side.
12. The lower end of the support column underneath the luggage rack should be sealed with Pro-Seal.
13. The vertical leather seal between wing and fuselage should be replaced by a rubber strip in accordance with fig. 1.

The flanges on the sheet metal plating at the pitot tubing passage through the fuselage covering should be hammered down in front of the sealing in accordance with fig. 2. Seal with Pro-Seal at the pitot tube connection.

14. The rubber strips, intended to seal the cabin at the windshield and at the rear edge of the left entrance door, should be moved according to fig. 3.
15. The canvas bags for the wingflap and landing gear push-pull rods should be secured to the rods by strong thread at the passages through the main spar. In doing so the flaps must be down.
16. In aircraft where the lining at frame 3800 consists of aircraft fabric this should be replaced by pegamoid.
See that most efficient sealing is obtained at the following points.
17. The joint between wing and fuselage forward of the mainspar at the rubber strip in the covering and the bakelite sealing in the wing nose.
18. Passages through the firewall.
