MODIFICATION BULLETIN

AIRPL
MODEL
91
Safir

91. 1/1

Fuselage Reinforcement of forward fin attachment to frame STA 6550

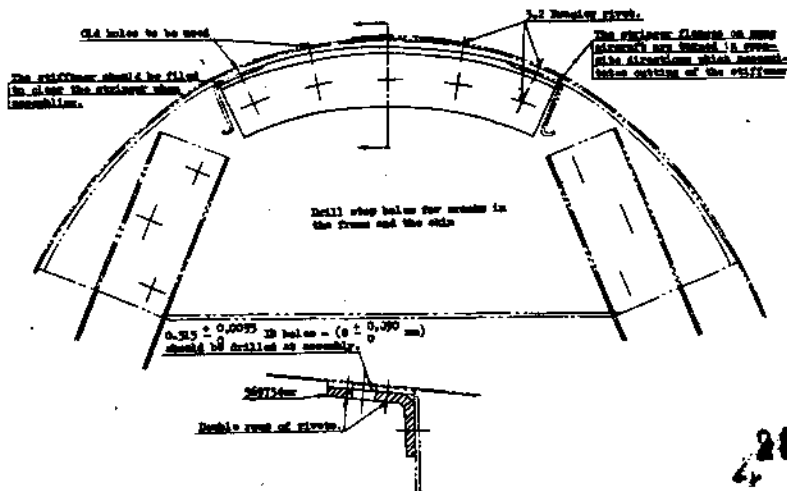
Occasionally the forward fin attachment has caused development of cracks in the flange of the frame, STA 6550. For this reason a stiffener should be installed, which is to be riveted to the frame flange, and the existing bolt replaced by a new one.

Should the skin be damaged, a reinforcement sheet should be riveted to the upper side of the fuselage, Aluminium 3526-38. The dimension of the reinforcement should be 0,023" x 2,95" x 2,95".

Remove the nut from the fin attachment bolt.

Drill out the rivets from the frame flange between the two upper stringers.

Install the stiffener between the stringers.

Rivet the stiffener, using the existing holes and drill new holes required.

If the skin is cracked the fin should be removed and a reinforcement installed in the upper side of the fuselage. 3.2 brazier rivet, spacing approximately 0,78".

Secure the fin, using the new bolt for the forward attachment.
