SERVICE BULLETIN

Date: Sept 1982 No 91.1.004 Issue 2
(Supersedes No 91.1.004)

Aircraft: SAAB SAFIR 91B, 91B2, 91C and 91D

Subject: Inspection of elevator spar.

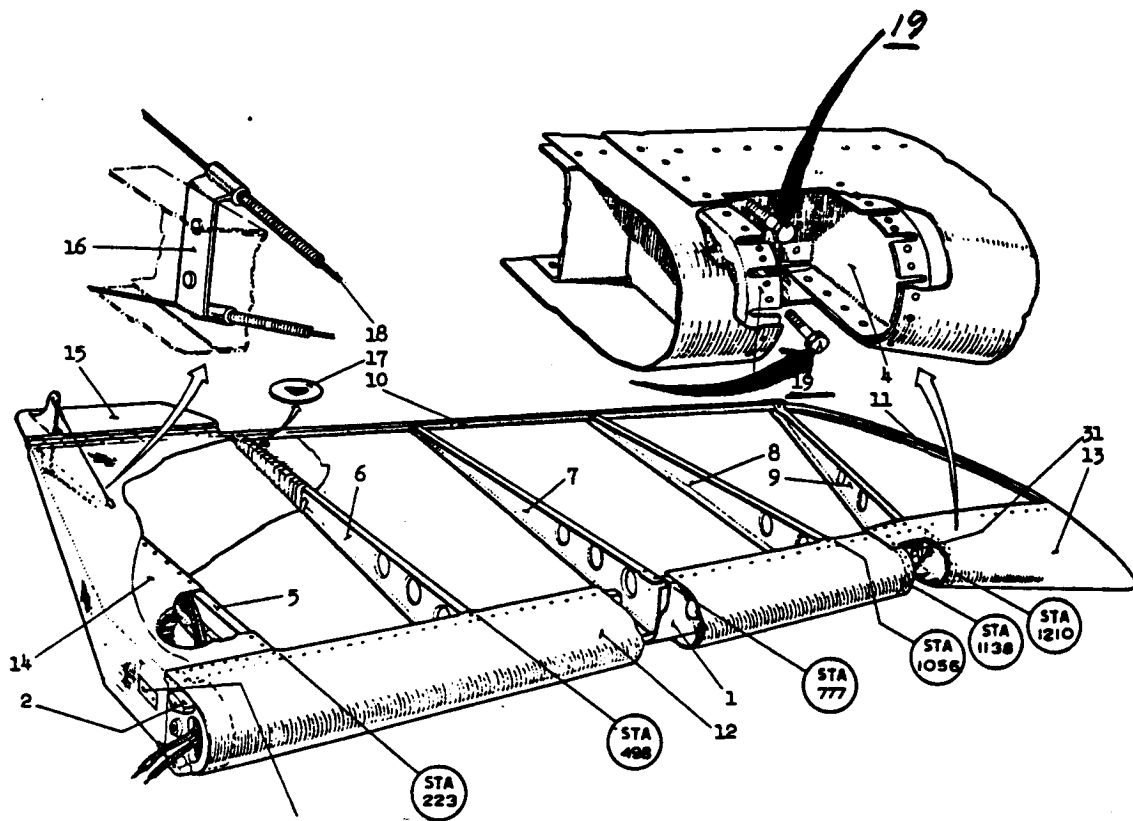
Reason: Damage to elevator spar at bearing assy attachment.

Work procedure: Inspect the attachment of the bearing assy LH and RH elevator for cracks and deformations. Special attention shall be given to the area where the attachment bolts (item 19) are located. See enclosed figure on page 2. Cracks and deformations most probably will start at the flange of the rear side of the spar opposite the anchor nuts for the bolts (item 19). For inspection cut a hole with a diameter of approximately 25 mm in the fabric just behind the flange of the spar and right behind the bolts (item 19).

Use lamp and mirror to inspect the flange and the area where the anchor nuts are located.

If cracks or deformations are found, the elevator must be replaced or repaired.

If no damage is found the fabric should be repaired by patching the hole.
