MODIFICATION BULLETIN

AIRPL
MODEL
91
Safir

91.3/1
91.3400/1

Elevator, Replacement of coupling plate

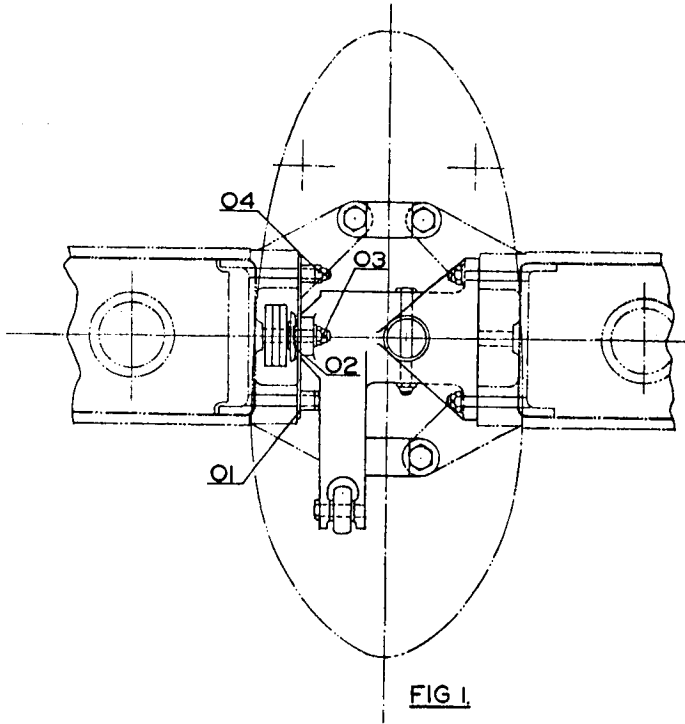
At certain RPM the elevator will vibrate violently sideways. This has in one case resulted in that the stabilizer rib at the outboard elevator bearing has cracked in the bend and that the inner rivets have been pulled out.

Unfasten the nuts, items 03 and 04 and remove the coupling plate, item 01 according to fig. 1.

Install the new coupling plate 562738, item 01, using a required quantity of washers, item 02, in accordance with fig.1 so that the coupling plate will be secured axially by the center bolt.

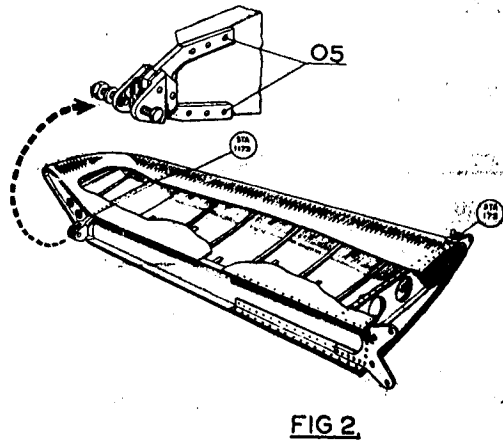
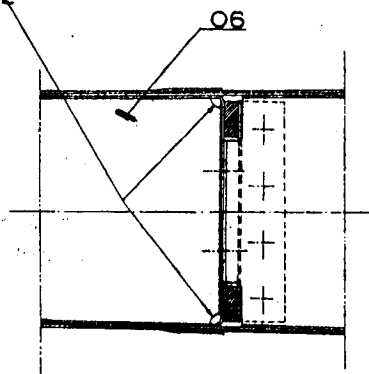
THESE CUT-OUTS SHOULD BE ENLARGED BY FILING IN ORDER TO FACILITATE THE INSPECTION OF EVENTUAL CRACKS.

Drill two inspection holes 1,8 in. (ϕ 30 mm) in the panel, item 06 and enlarge the opening adjacent to the rib by filing.

Thereupon check that the rivets, item 05, are not loose and that no cracks exist in the bend of the rib.
