Modification
Bulletin

Aircraft Type
91 Safir

Reference <u>Rudder</u> Introduction of reinforcements at ribs	Date Oct. 30, 1958	No 91.3/3
	Soab Service Dept. C Larsson	
	Soab Design. Dept. J Boklund	Page 1 of 2
Urgency IV	Royal Swedish Board of Civil Aviation S Fogelström

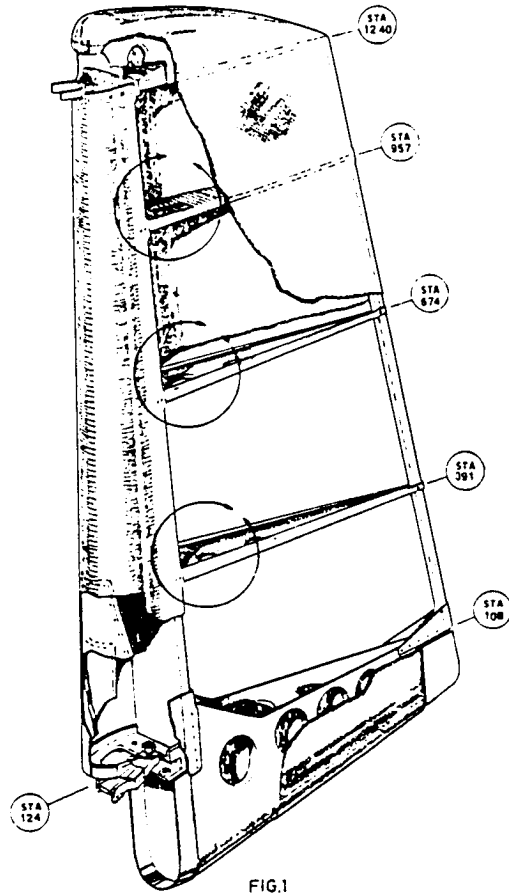
FIG. 1

Damage which can cause abnormal weakness in the rudder has been observed at the rib attachments to the rudder spar.
In case damage is detected stiffenings are to be installed.

Check that the rudder trailing edge is not bent. Push the rudder close to the stop blocks and check for abnormal weakness in the ribs by pressing gently on the trailing edge at rib Sta 391, Sta 674 and Sta 957, see fig 1. If the fabric covering thereby creases the rib attachments are damaged.
If damage is observed proceed as follows:
Dismount the rudder.
Cut up the fabric covering.
Rivet the reinforcements to the ribs according to fig. 2, after having straightened the nose plate flange at the reinforcements.
Sew up the covering and cement a fabric strip over the seam.
