Modification Bulletin

Reference 91D. Safir. Oil System Replacement of oil line, oil cooler.	Date 2 februari 1961 Saab Service Dept.	No. 91.4/8	
	C Larsson Saab Design. Dept.		
	S Lundgren		
Urgency IV	Royal Swedish Board of Civil Aviation S Fogelström		
Marking -	Effect on weight distribution		
	Weight change lbs	Station In.	Moment change lbs.in.
	-	-	-

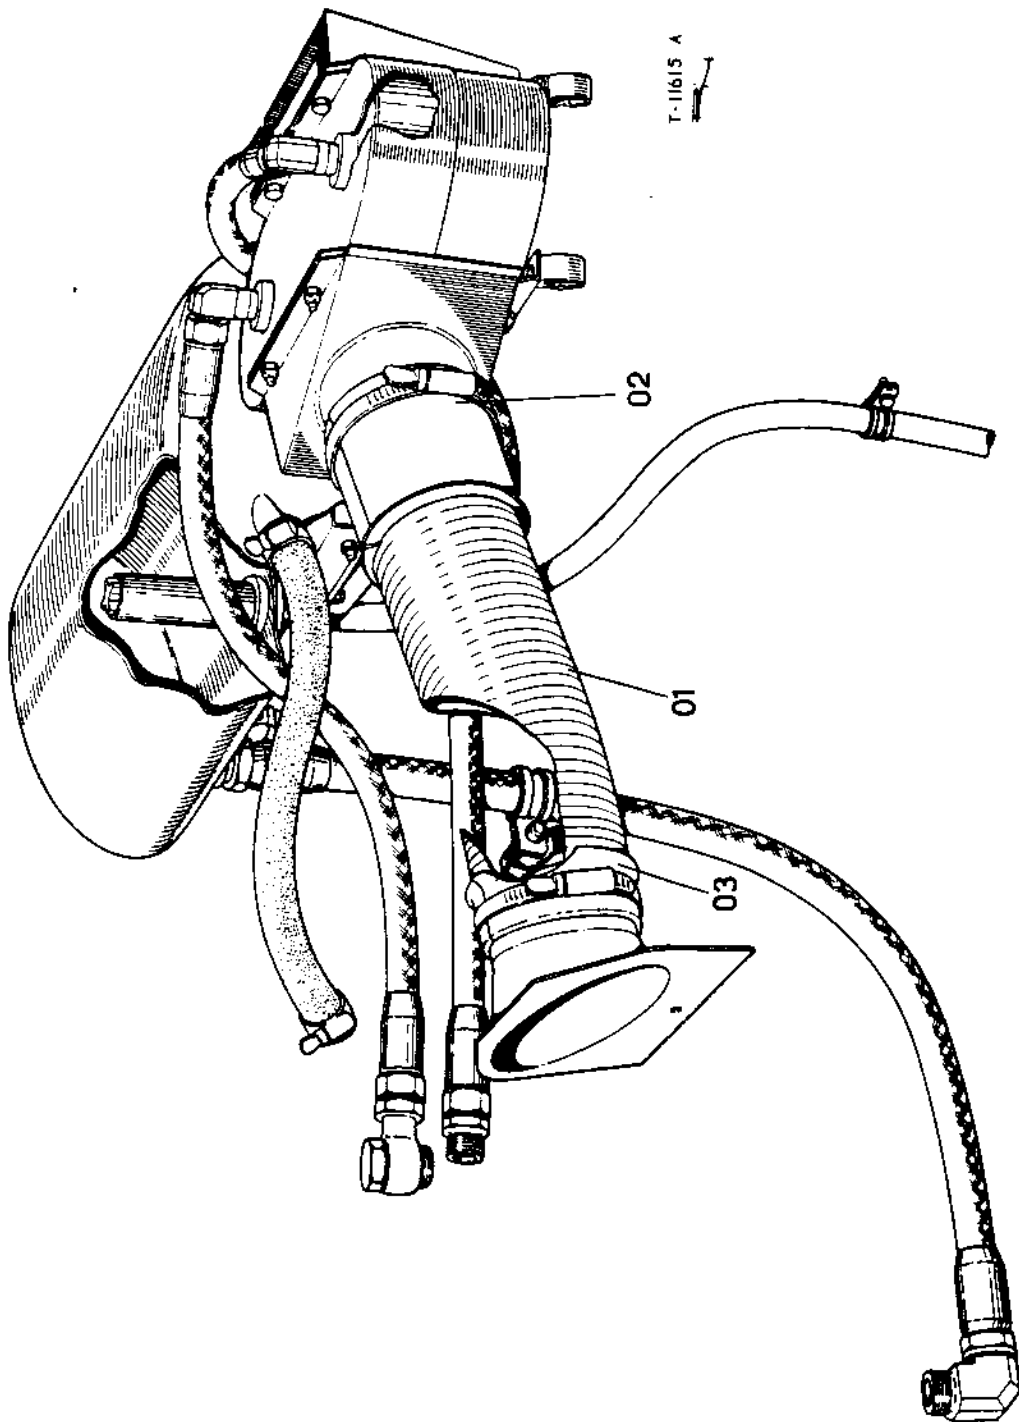
In some cases cracks have arisen in the oil cooler air intake owing to that the metal oil line between the oil cooler casing and the air intake has been too rigid. For that reason the metal oil line can be replaced by a new one of Flexflyte type L-9.

Loosen the clamps and remove the oil line.

Move the existing sleeve item 03 to the connection between the new hose item 1 and the air intake and fit the new sleeve item 02 according to the figure. Fit the hose with existing clamps.
