MODIFICATION BULLETIN

91
Safir

Power plant: Modification of the exhaust manifold

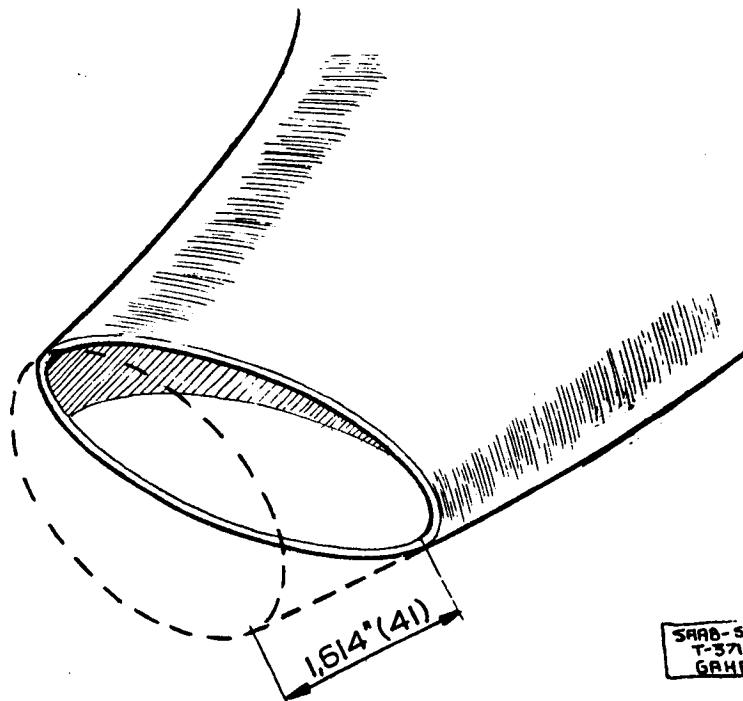
The reverse pressure of the exhaust manifold has proved to be too great, and therefore during the exhaust stroke No. 4 cylinder will not be adequately cleaned. For this reason the outlet area of the exhaust manifold should be increased by oblique cutting according to the figure below:
