# Modification Bulletin

Aircraft Type  
91B and C Safir

Reference  <b>Power Plant</b>  Changed location of the manifold pressure connection	Date December 10, 1956	No 91.6/14
	Saab Service Dept. C Larsson	
	Saab Design. Dept. A J Andersson	Page 1 of 1
Urgency IV	Royal Swedish Board of Civil Aviation S Fogelström

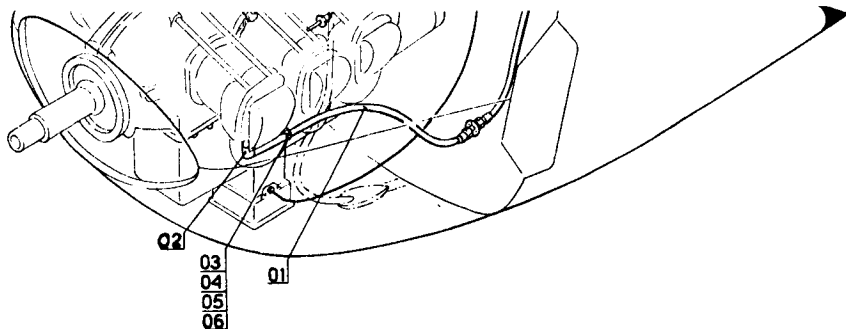
The present location of the manifold pressure connection gives incorrect measuring values. Because of this the connection is to be moved from the oil sump (at the carburetor attachment) to the connection for the priming line on cylinder No. 2 according to the manufacturer's recommendations.

Remove the hose between the coupling on the oil sump and the fire-wall and then remove the coupling. Remove the plug from the connection for the priming line on cylinder No. 2 and install it on the oil sump. Fit angle tube item 02 on cylinder No. 2 and hose item 01 between the angle tube and the fire wall. Attach the hose in the same way as the previous hose and clamp it also to the front manifold pipe on the engine.
