Reference 91B, 91-B2, 91C Safir Propeller Hartzell HC with plastic blades  Introduction of a sheet bushing of teflon.	Date March 29, 1960	No. 91.6/18
	Saab Service Dept. C Larsson Saab Design. Dept. J Boklund	
Urgency IV	Royal Swedish Board of Civil Aviation LFS	
Marking -	Effect on weight distribution	
	Weight change lbs	Station in.
	-	-
		Moment change lbs.in.
		-

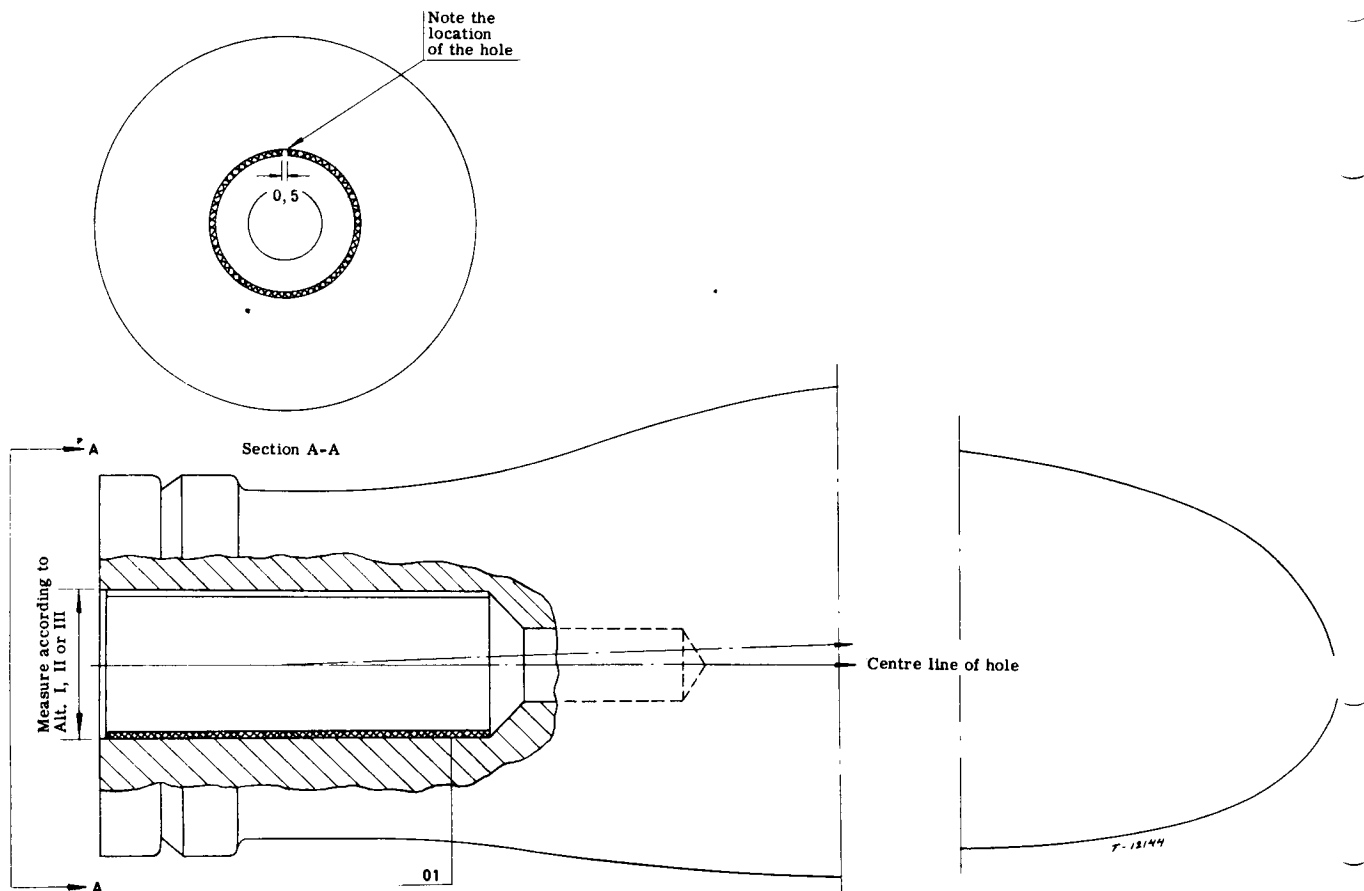
Item	Figure
01 2	Teflon sheets 0,75 <sup>+ 0</sup> - 0,02 x 100 x 130

In case of damage e.i. excessive play in the hole of the blade root, or seizure between the blade root and the guide sleeve, a sheet bushing of teflon can be introduced instead of an oversize guide sleeve, see attached figure.

Adjust the sheet of teflon to fit in the hole so a play of 0,5 mm according to view A-A in the figure is obtained.  
Loosen the clamps and fit the blades and the clamps to the propeller hub.  
Tighten the screws according to Hartzell Hydro-Selective Propeller Manual Model HC-12x20, section VIII, para. A3d and F.
