<p>Reference</p> <p><u>Airplane 91B, -B-2 and C, Exhaust system RH</u></p> <p>Repairing of Exhaust Pipe.</p>	<p>Date</p> <p>December 30, 1960</p> <p>Saab Service Dept.</p> <p>C Larsson</p> <p>Saab Design. Dept.</p> <p>J Boklund</p>	<p>No.</p> <p>91.6/19B</p>						
<p>Urgency</p> <p>IV</p>	<p>Royal Swedish Board of Civil Aviation</p> <p>Lfs</p> <p>S Fogelström</p>							
<p>Marking</p> <p>-</p>	<p>Effect on weight distribution</p> <table border="1"> <thead> <tr> <th>Weight change Lbs</th> <th>Station In.</th> <th>Moment change Lbsin.</th> </tr> </thead> <tbody> <tr> <td>-</td> <td>-</td> <td>-</td> </tr> </tbody> </table>		Weight change Lbs	Station In.	Moment change Lbsin.	-	-	-
Weight change Lbs	Station In.	Moment change Lbsin.						
-	-	-

Exhaust pipe 1075953-2

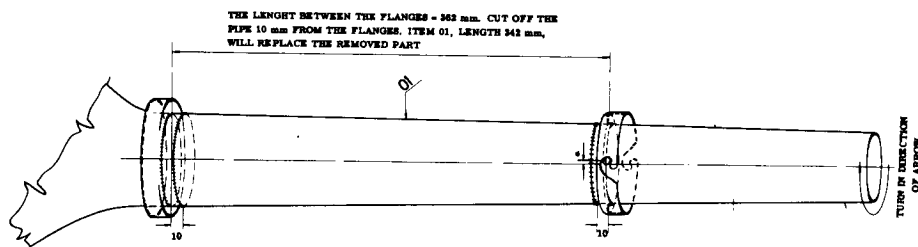
Burns can occur on the part of the exhaust pipe covered by the carburetor air preheating chamber. For this reason the exhaust pipe can be cut off and replaced by a pipe of thicker material.

Cut off the pipe 10 mm from the flanges and weld the new pipe item 01 according to the figure.

Check before dismounting the exhaust pipe that the hose between the heat chamber and the mixture chamber of the carburetor is mounted without bend.

Adjust if necessary by turning the lower part of the pipe in direction of the arrow distance "a" when welding the new pipe.
