MODIFICATION BULLETIN

AIRPL
MODEL
91
Safir

91.6/2

Power plant: Replacement of carburetor air intake

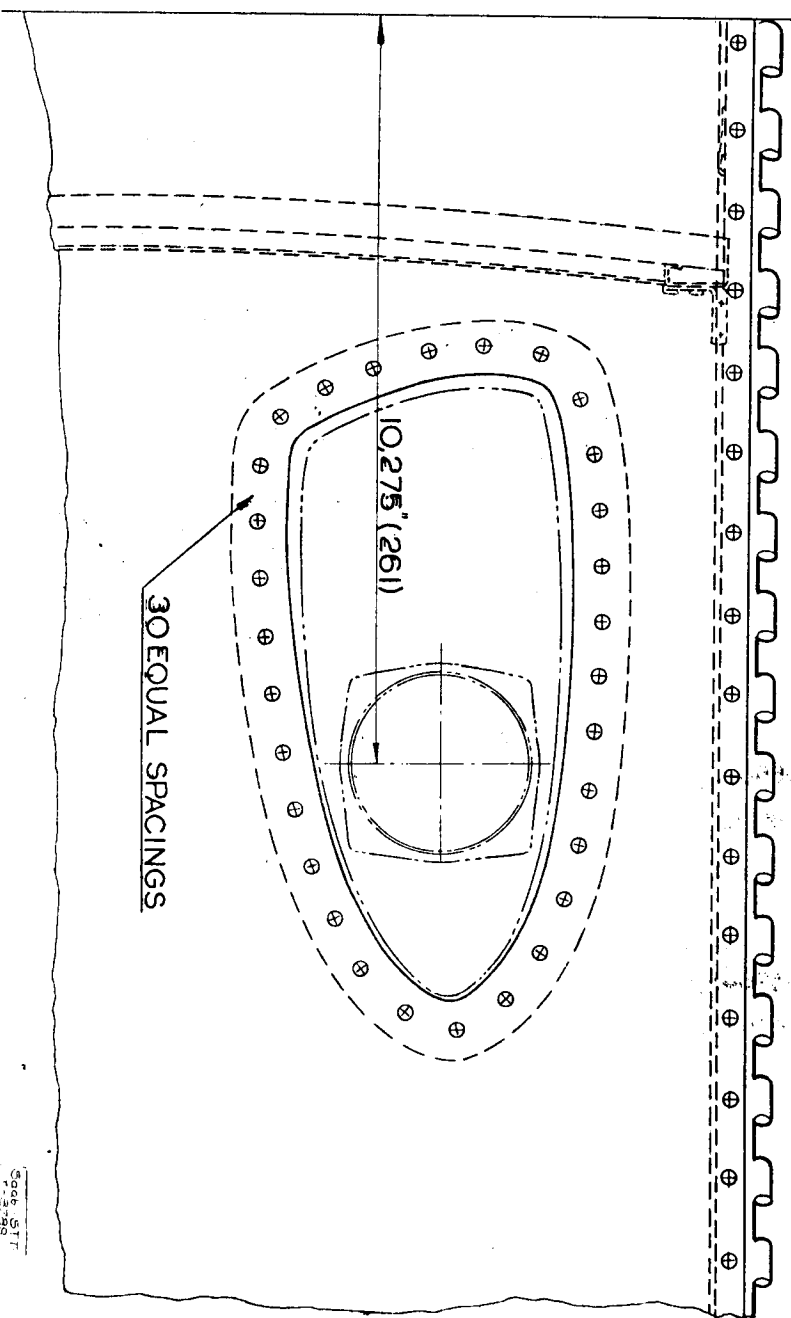
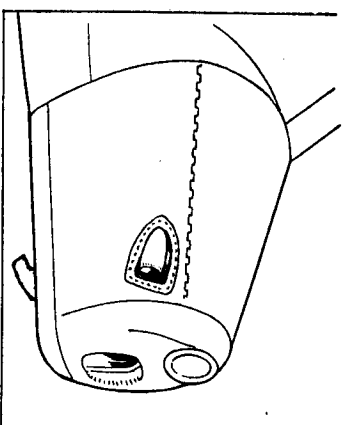
SIDE COWLING VIEWED FROM THE INSIDE

The air intake, which is attached to the right side cowling and forms a slot between the side cowling and the carburetor has occasionally caused engine trouble. For this reason the air intake is to be replaced by a redesigned one which shall be fitted to the carburetor and penetrate the side cowling. At the same time a hole is provided in the side cowling for the air intake and reinforced.

Provide a new hole in the side cowling and rivet the reinforcement plate according to fig.

Check, that an opening min. 0.20" exists between the air intake and the side cowling when closed.
