MODIFICATION BULLETIN

AIRPL
MODEL
91
Safir

91. 6/3

Engine cowling. Introduction of a leather cuff

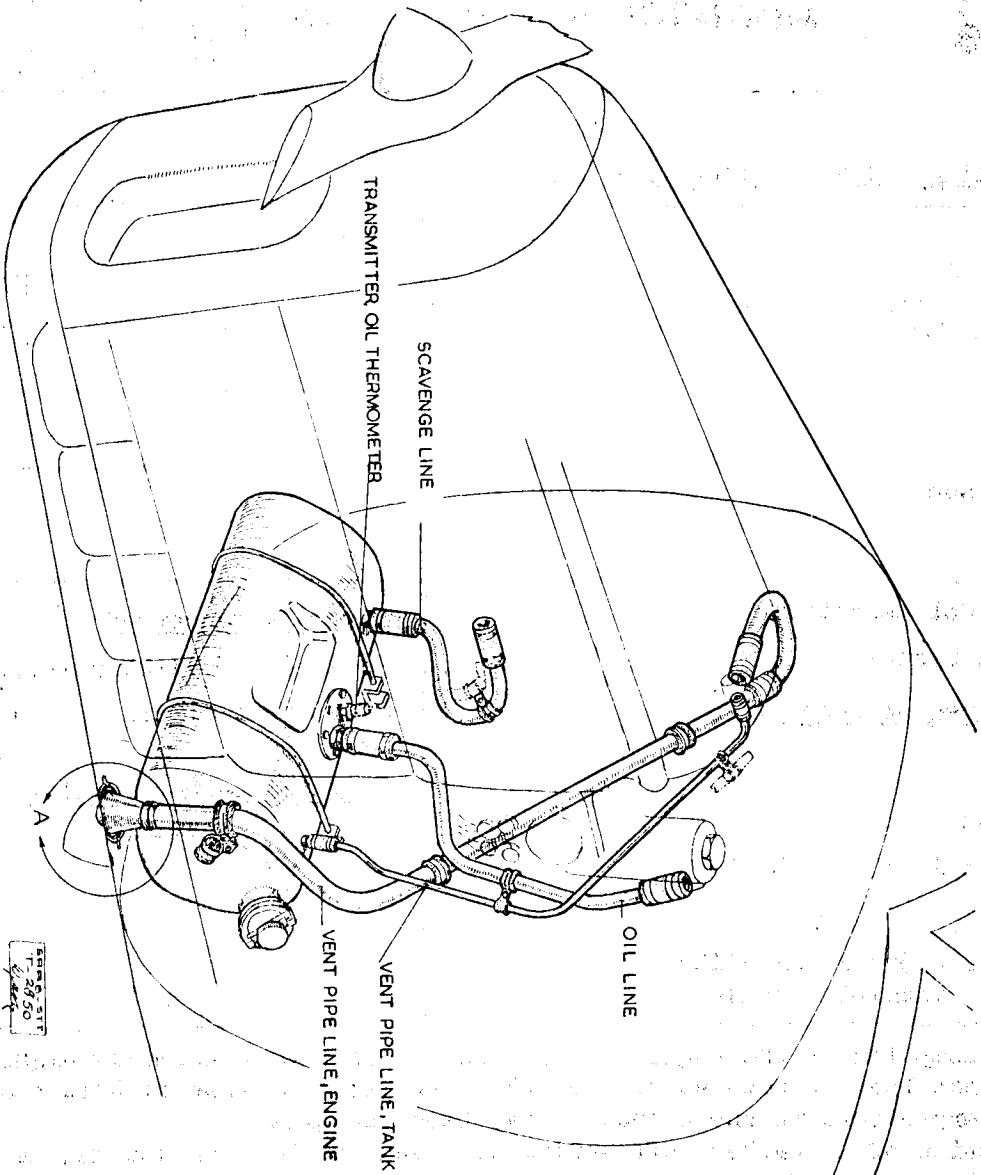
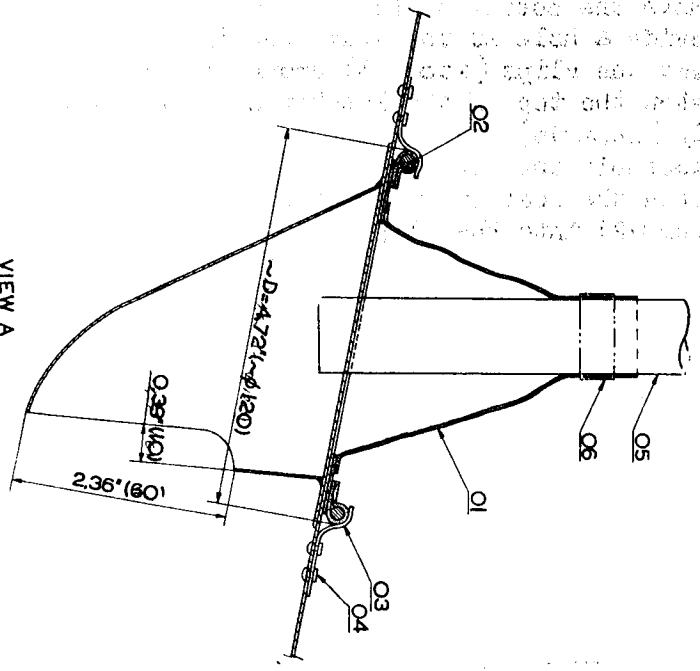
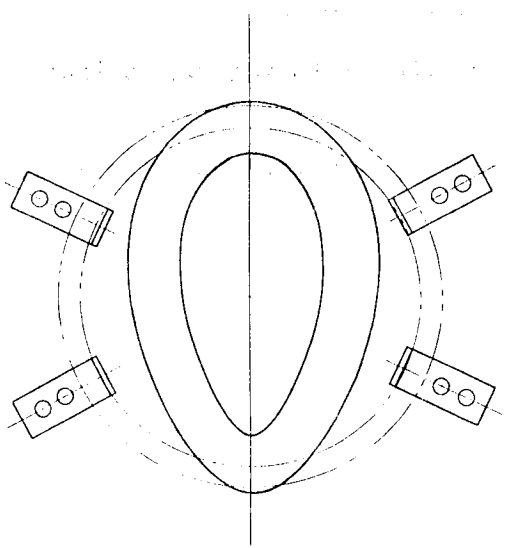
The oil consumption of the engine in some cases has been abnormally high. Furthermore there has been leakage at the propeller shaft. The cause of this has been that the overpressure in the crankcase has been too great.

By introduction of a leather cuff acting as a sealing between the engine vent line and the bottom plate of the cowling the oil consumption will be reduced and the leakage at the propeller shaft will stop.

Remove the bottom plate

Provide a hole at the drain cap in the bottom plate, see figure.

Rivet the clips (item 03) around the hole.

Fasten the top of the leather cuff to the vent pipe (item 05) using the existing clip (item 06).

Reassemble the bottom plate

Fasten the leather cuff (item 01) to the bottom plate by pressing the wire spiral (item 02) into the clips.
