| | MODIFICATION BULLETIN Replaces MB 91.6/4 | AIRPL MODEL | 91.6/4B |
| | | 91 Safir | PAGE 1 OF 2 |

Engine Gipsy Major I and X. Replacement of rocker bracket bolts.

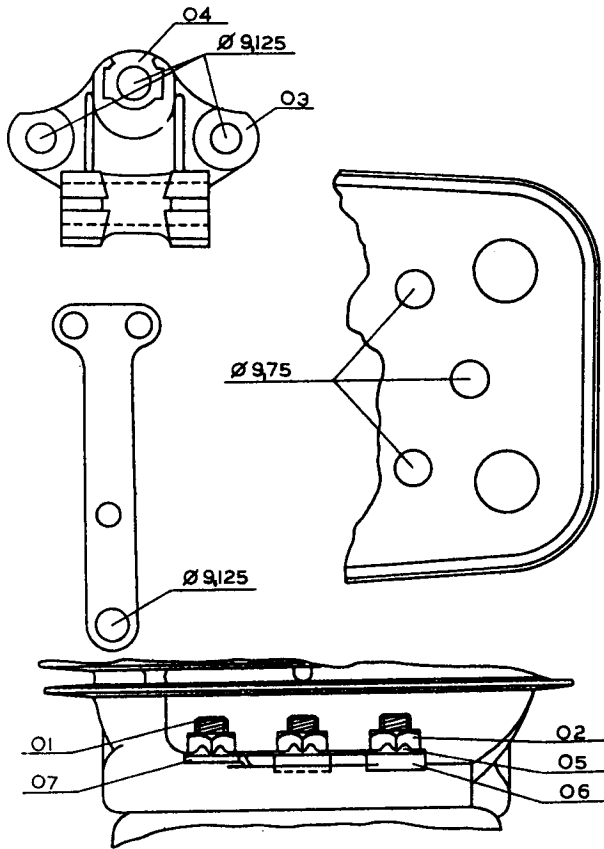
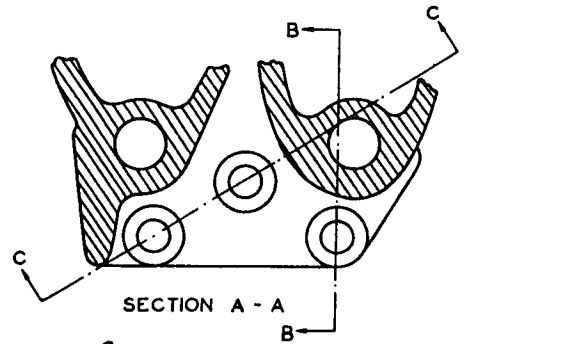
FIG. 1

According to the engine manufacturer the nuts for the rocker bracket bolts may be tightened too much in order to be able to fit the cotter pins. Too tight nuts may cause failure of the bolts.

Install bolts, washers, spacers, lock plates and nuts in accordance with figs 1 and 2 respectively.

The tab washer under the bolt head should be located as shown in the figure.
