MODIFICATION BULLETIN

AIRPL
MODEL
91
Safir

91.6/5

Reinforcement of the oil tank mounting.

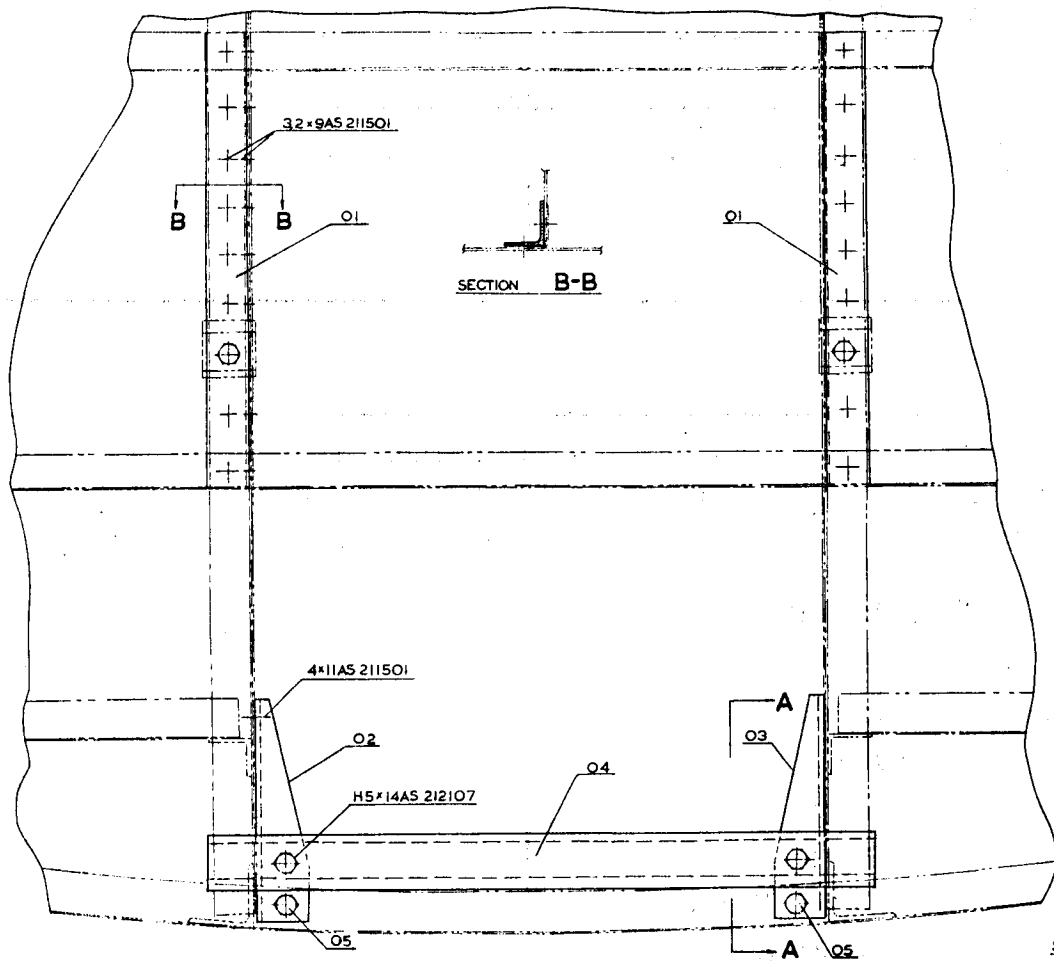
Owing to damages inflicted upon the firewall in attaching the oil tank, reinforcements should be installed according to the fig.

Remove the oil tank and the lower brackets 526452ur.

Drill out the rivets and rivet the stiffeners, item 01, to the wheel housing and fire wall in the cabin.

Use existing rivet holes.

Install the stiffeners, items 02 and 03, in the wheel housing and attach them at the upper end with a rivet, 4x11 AS 211501, each, and in the lower part with the bolts, item 05.

Install stiffener, item 04, on the firewall. In doing so use existing bolts M5x14 AS 212107 and nuts.

Reinstall the oil tank.

Note: In case cracks appear in the firewall, stop holes should be drilled. In case of several cracks a reinforcement of 0.0315" stainless steel should be riveted to the forward side of the firewall.
