MODIFICATION BULLETIN

AIRPL
MODEL
91
Safir

91.6/7

Exhaust Manifold. Lengthening and sealing.

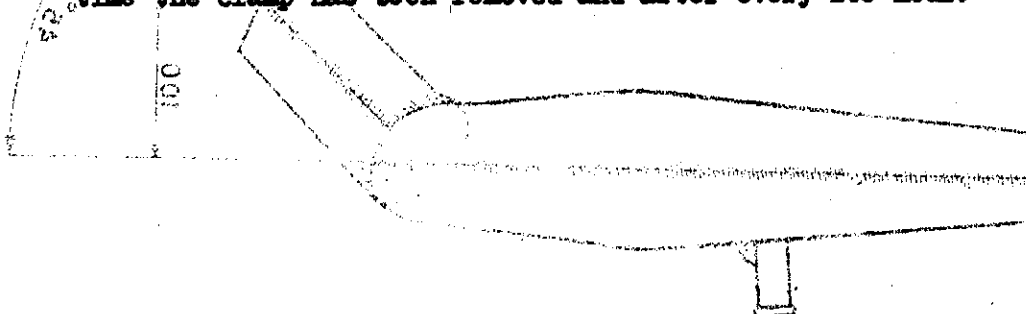
Since danger exists that carbon oxide will penetrate into the cabin, owing to the sweep-up of the exhaust gases along the sides of the fuselage, through openings in the cabin enclosure, the exhaust manifold is to be lengthened in order to avoid this inconvenience and the joint between the two manifold portions to be sealed. At the same time check the sealing in accordance with MB 91.1/5.

Remove the exhaust manifold. Weld the plate, item no. 03, in accordance with the fig. Seal the joint between the two manifold portions by attaching the clamp, item no. 01, together with gasket, item no. 02, and ring, item no. 04, by means of screws.

Note: The gasket, item no. 02, and the ring, item no. 04, should be replaced each time the clamp has been removed and after every 100 hour.
