MODIFICATION BULLETIN

AIRPL
MODEL
91B

91.6/8

Engine mounting. Moving of manufacturing plate

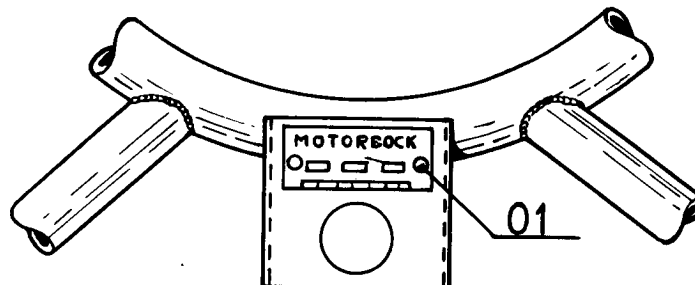
Due to corrosion having occurred underneath the manufacturing plate for the engine mounting this plate should be moved to the bracket for the mixture control.

Remove the manufacturing plate and clean the engine mounting free from corrosion and apply protective paint.

Secure the manufacturing plate to the bracket for the mixture control on the underside of the mounting in accordance with the figure below.
