Svenska Aeroplan Aktieföretaget

service bulletin

No. 91.6.001

AIRPLANE 91A SAFIR

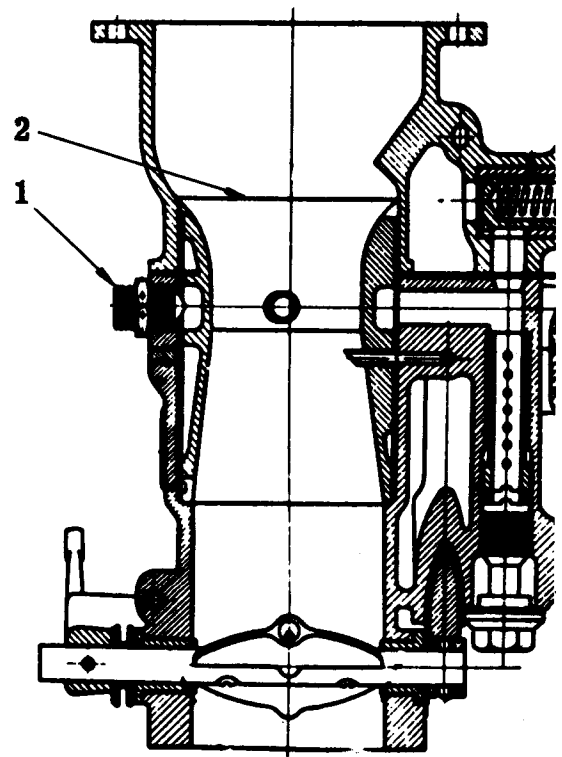
1. Choke screw
2. Choke tube

REASON: The choke screw (1), holding the choke tube (2) in proper position, has loosened in one separate case although the locking was undamaged. Due to engine vibrations the choke tube has then worked down into the material of the choke housing, causing the choke nozzles to sink down. Thus the carburetor has delivered an incorrect mixture, resulting in malfunctioning of the engine.

PROCEDURE: Check the location of the choke tube as follows:

1. Remove the choke screw locking wire.
2. Slacken the lock nut and remove the choke screw.
3. Check the hole in the choke tube to match with the hole for the choke screw and see that the choke screw is undamaged.
4. Tighten the choke screw and lock carefully the nut with locking wire.
