service bulletin

No. 91.6.004

AIRCRAFT SAAB SAFIR 91B, 91-B2 AND 91C EQUIPPED WITH HARTZELL PROPELLERS.

SUBJECT: Supplementary instructions for inspection of the propeller.

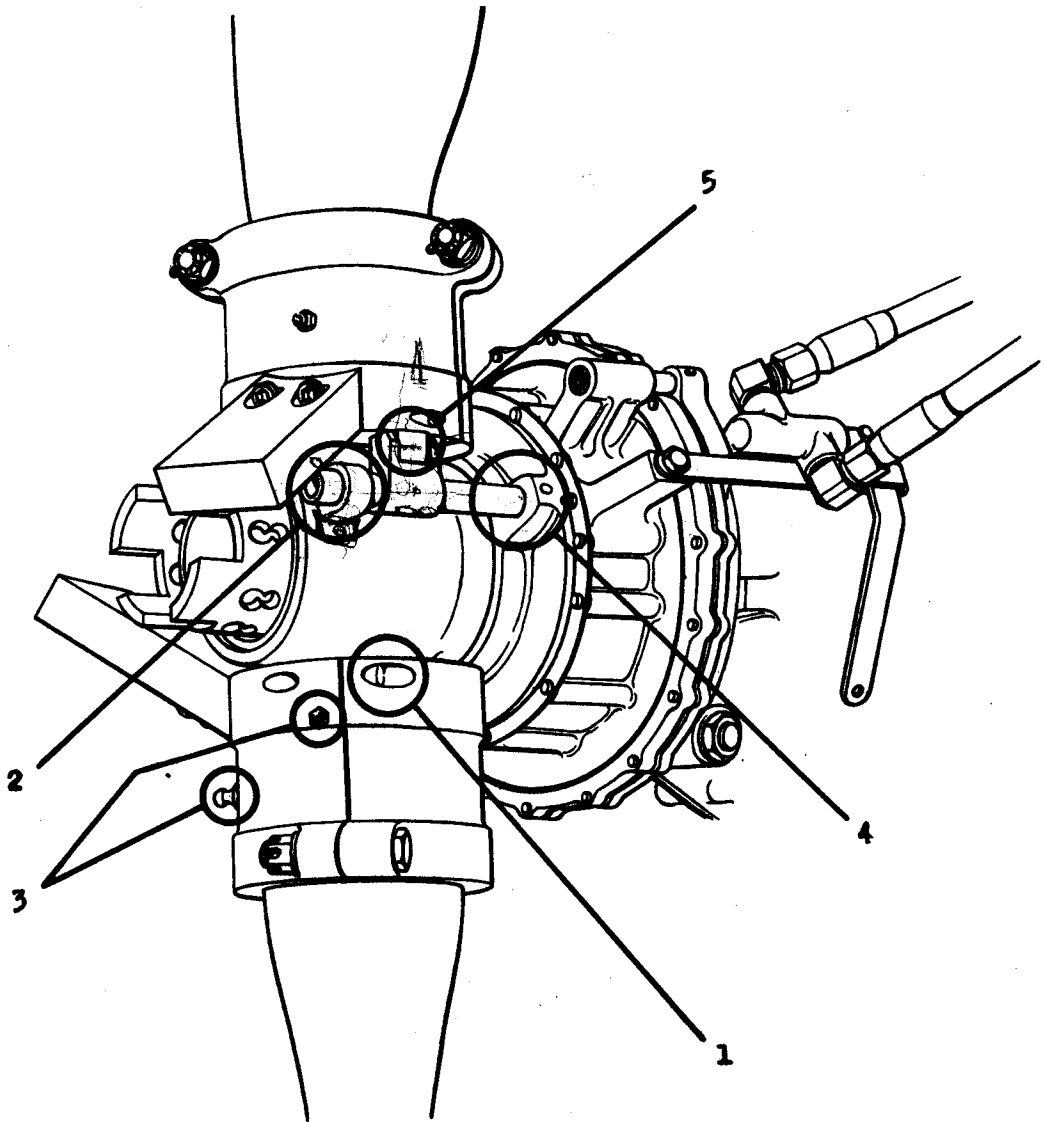
Figure 1

WORK PROCEDURE: The propeller should be carefully inspected according to Airplane Manual and Hartzell Manual section V. Particular attention should be paid for cracks in the blades. Service experience has shown that the following areas, see figure, are especially critical for cracking:

1. Around the counterbore for the Allen screw, part No. A-282 in the blade clamps C-3 (C-66-1B, 838-12 or 838-14 according to Saab Spare Parts catalogue).
2. The push rod A-97 and the lugs on hub C-157 for this push rod.
3. Around the zerk fittings.
4. The fittings for the push-rods on jack-plate B-87-1 and B-87C-1.
5. The old type of link screw part No. A98B.

Propellers with plastic blades should also be carefully inspected for cracks in the leading edge metal protection, in the plastic material aft of the metal protection and at the root of the blade. In doubtful cases fluorescent or dye penetrant inspection methods should be used.
