service bulletin

No. 91. 6. 005

AIRCRAFT SAAB SAFIR 91B AND 91C, MANUFACTURING NR 91. 201-91. 320

SUBJECT: Dividing of LH and RH baffle plates in engine cooling system.

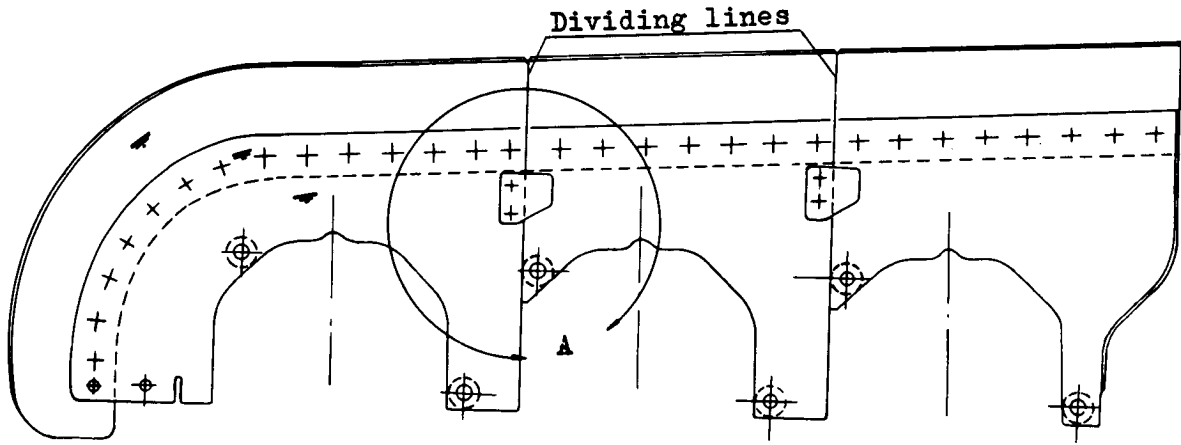
RH baffle plate

REASON: Cracks may develop in the baffle plates.

Divide the baffles and rivet supporting lugs to them according to fig. 1. The dividing lines may be slightly altered to provide sufficient edge distance at old rivets and screw holes. If the space for shim 1077856ur is insufficient, reject the shim and rework spacer 1077127 according to fig. 2.

Drill out the predrilled holes in the baffles to \varnothing 6,5 mm to fit the attaching holes on the engine. Divide the baffles and rivet supporting lugs to them according to fig. 1. The dividing lines may be slightly altered to provide sufficient edge distance at old rivets and screw holes. Spacer 1077127 and shim 1077856ur can be used, but in that case the predrilled holes shall be drilled out to \varnothing 8,5 mm.
