# service bulletin

No. 91.6.007

AIRCRAFT SAAB SAFIR 91B, 91B-2 AND 91C

**SUBJECT:** Carbureter Marvel-Schebler MA 4-5.

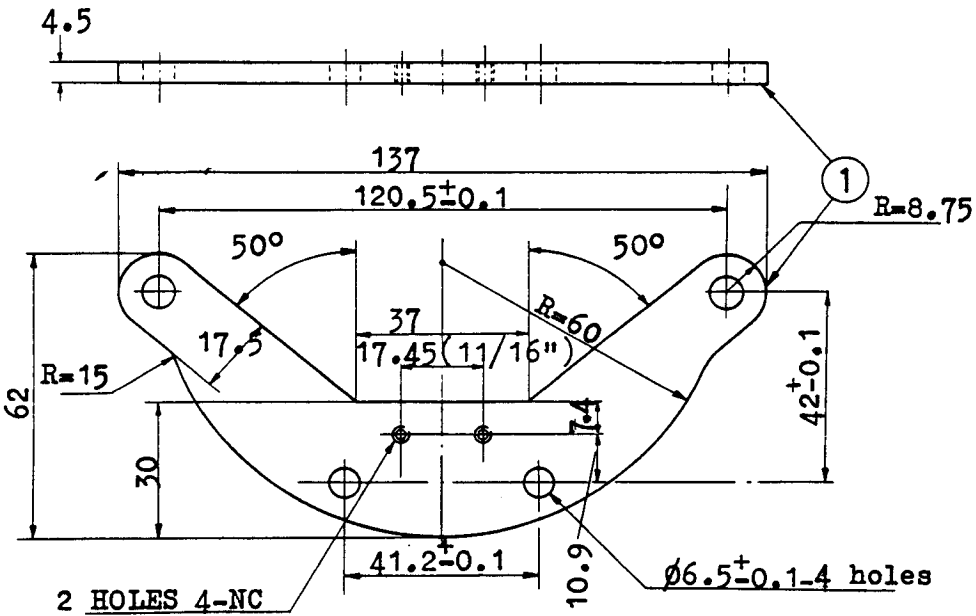
Figure 1

Assemble float and lever assembly to fixture according to fig. 1, using float lever shaft. Screw the fixture to fuel bowl using 4 screws according to fig. 2. By moving the floats up and down when holding the bowl in different positions any contact of floats with the walls of fuel bowl can be detected. If contact is detected, the float lever must be adjusted to obtain at least 1 mm clearance between floats and fuel bowl.

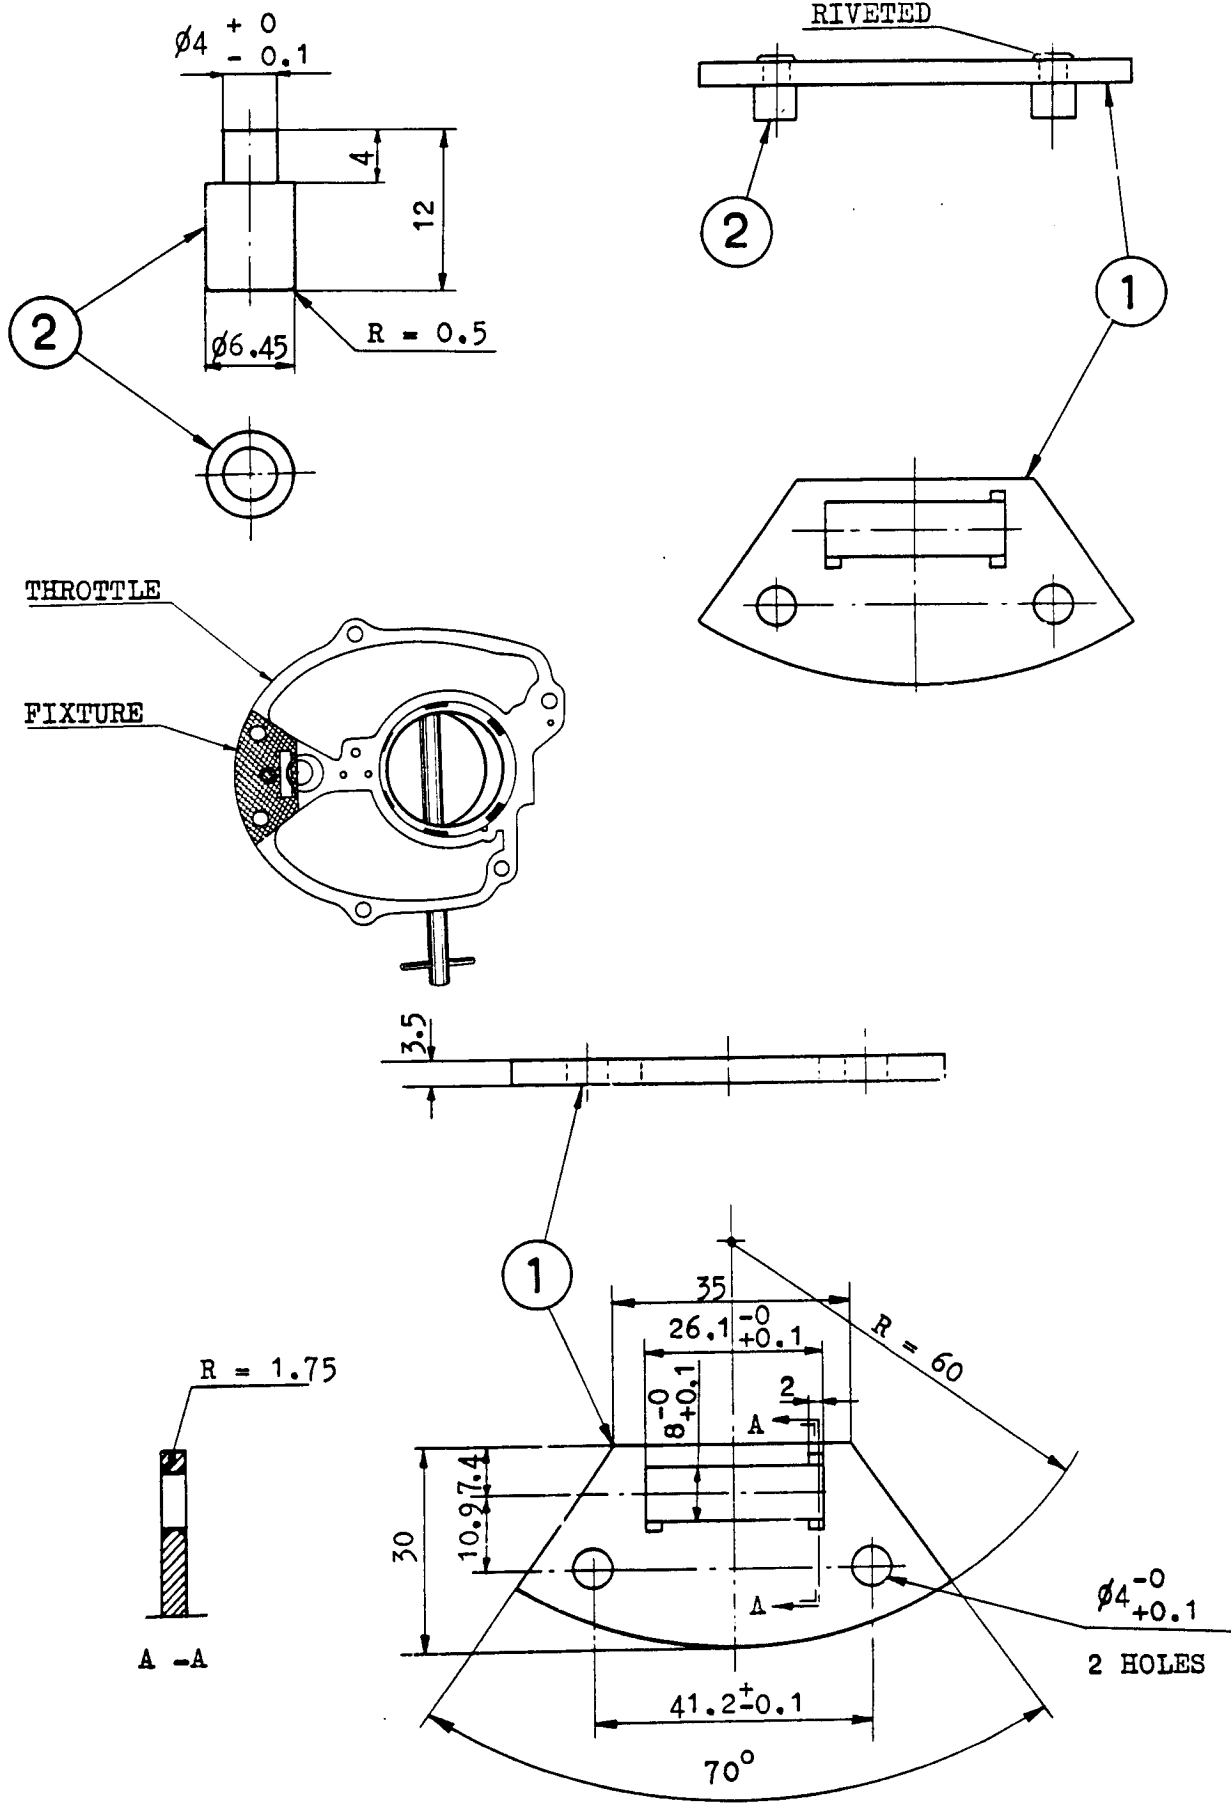
FIGURE 3

Check position of the float bracket in relation to throttle body with fixture according to fig. 3.

If adjustment is necessary remove solder on float bracket screws, loosen the screws and locate the bracket according to fixture.

Tighten the screws and secure them with solder.
