Svenska Aeroplan Aktiefolaget

No. 91.6.010

AIRCRAFT SAAB SAFIR 91B AND 91C.

SUBJECT: Exchange of metal propeller blades for plastic blades with rubber lining on leading edge.

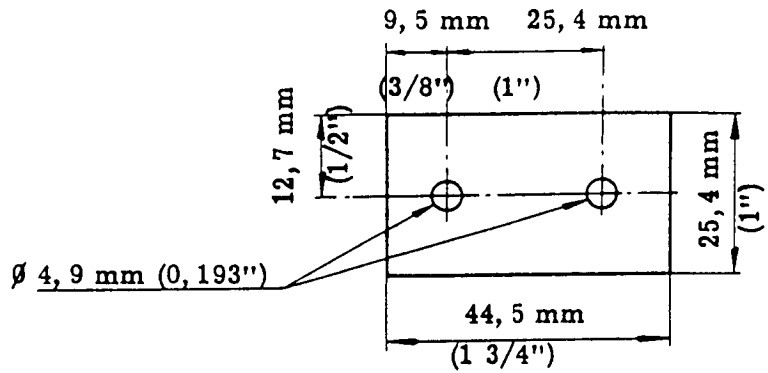
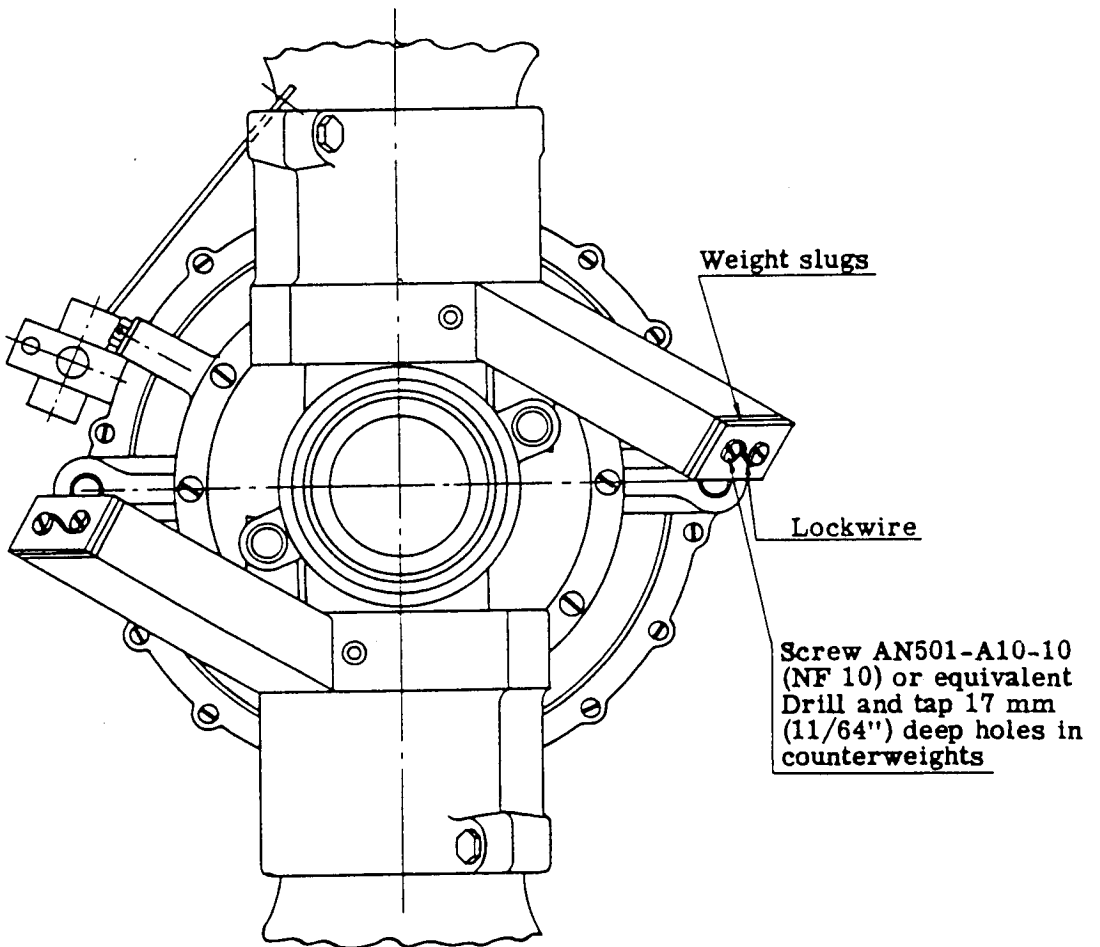
The difference between clamps for metal blades and clamps for plastic blades is that plastic blades require heavier counterweights. Metal blade clamps can be modified to suit plastic blades by adding weight slugs to the counterweights according to the figure..

Weight slug (4 required
per propeller)
Thickness = 2 mm (5/64")
Cadm. plated carbon steel
or stainless steel
