No. 91. 6. 017/B

Saab Safir 91B, 91B-2, 91C and 91D

SUBJECT: Exchange of sealings in auxiliary fuel pump with filter SA-1076238.

Availability of an improved type of clamps for the filter bowls.

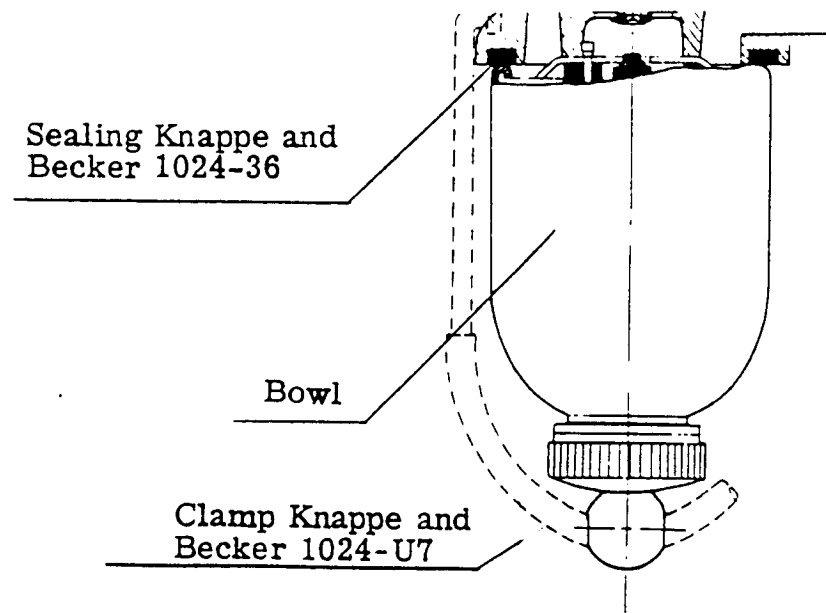
Figure 1

REASON: When replacing the filter bowls after draining of the fuel filters it may happen that the bowls do not seal against the pump body.

The reason is that the rubber sealings in the previous material (Dichtring 1024-36 according to spare parts list 1024 B of Knappe and Becker) between the bowls and the pump body are permanently deformed of the sealing edges of the bowls.

The leaking can cause air to enter the fuel system causing low and flickering fuel pressure.

Sealings of type 1024-36, see figure 1, shall be exchanged for new ones of better quality as soon as possible, either made by SAAB, P/N 1155687, or made by the pump manufacturer Knappe and Becker, PN 1024-36. Knappe and Becker has not changed the part number, but all future deliveries will be of the improved quality.

Note: Old stock of sealing 1024-36 should be scrapped.

a. That the sealings will fit properly in the grooves of the pump body and are not permanently deformed (of the sealing edges of the filter bowls). In this case exchange the sealings for new ones.
