SAAB 91 SAFIR SERVICE BULLETIN

Number: 91.6.023

Subject: Inspection and replacement of crankshaft front thrust bearing

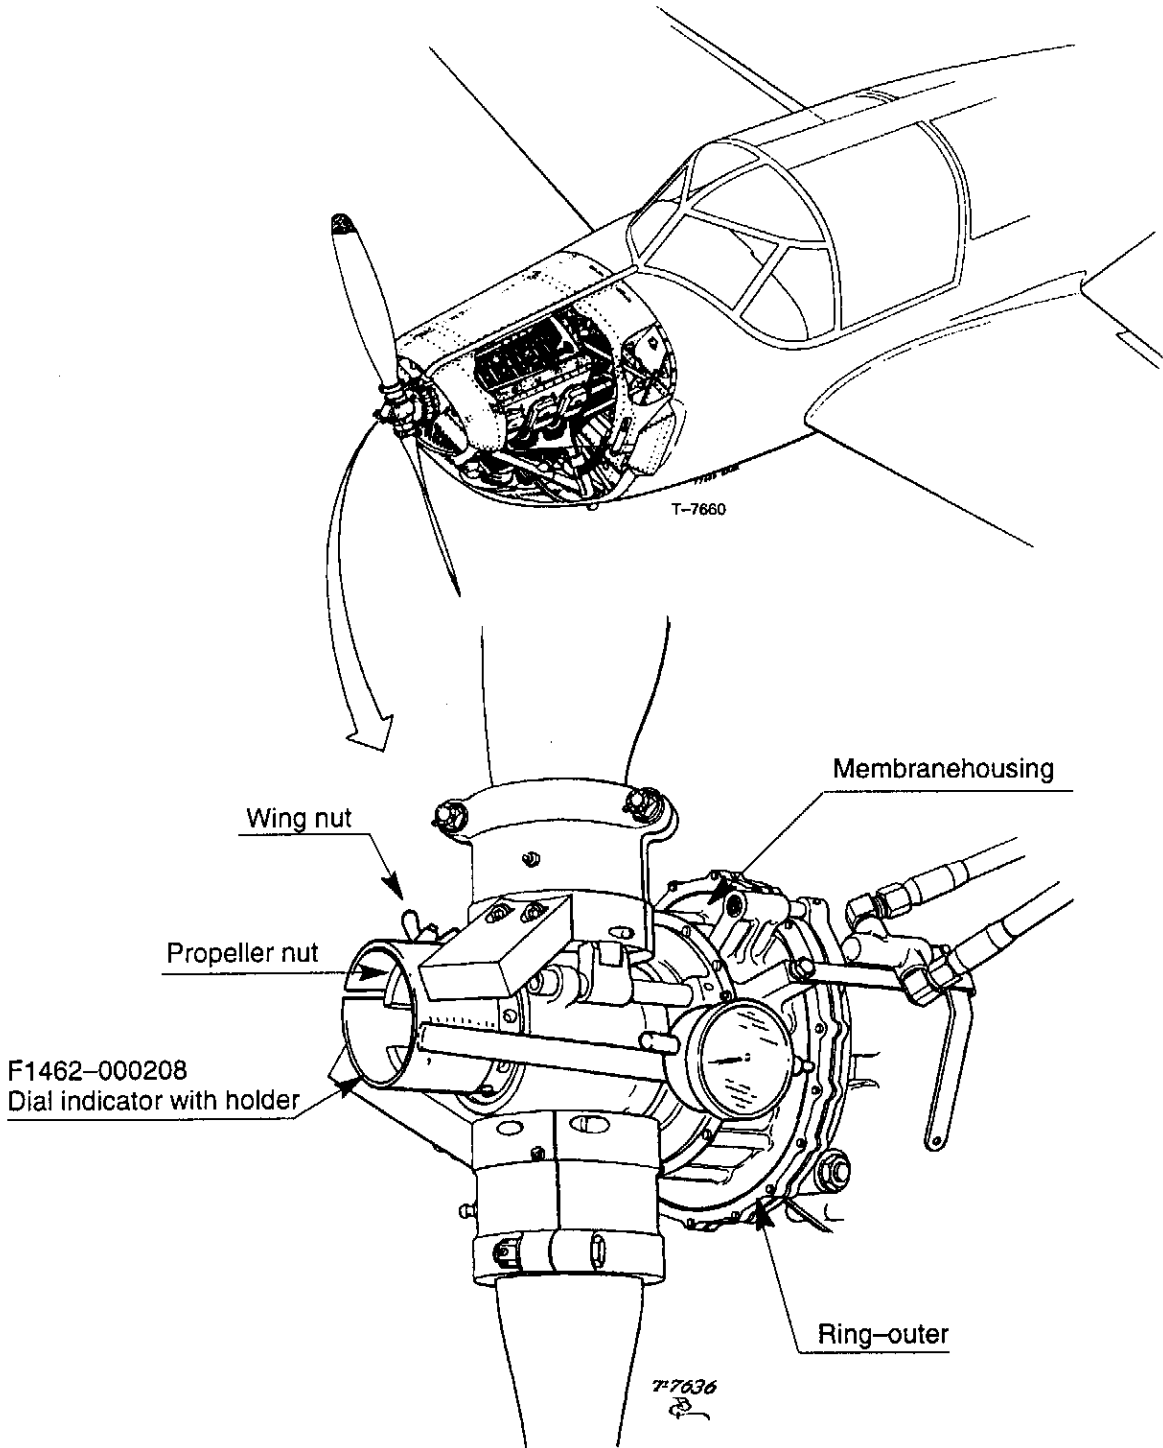
Figure 1.

- 1 Run up the engine to normal take off temperature.
- 2 Install the dial indicator with holder to the propeller nut and tighten with the wing nut, see figure 1.
- 3 Fix the dial indicator sensor to ring-outer at the membranehousing, see figure.
- 4 Push the propeller towards the crankcase and set the dial indicator to zero.
- 5 Pull the propeller powerfully in the flight direction and read off the indicated allowance. Maximum permissible play: 0,30 mm.
- 6 Push back the propeller towards the crankcase and check that the dial indicator reads zero.
- 7 Repeat the measuring and check that previously measured value is repeated.
- 8 Remove the dial indicator with holder.

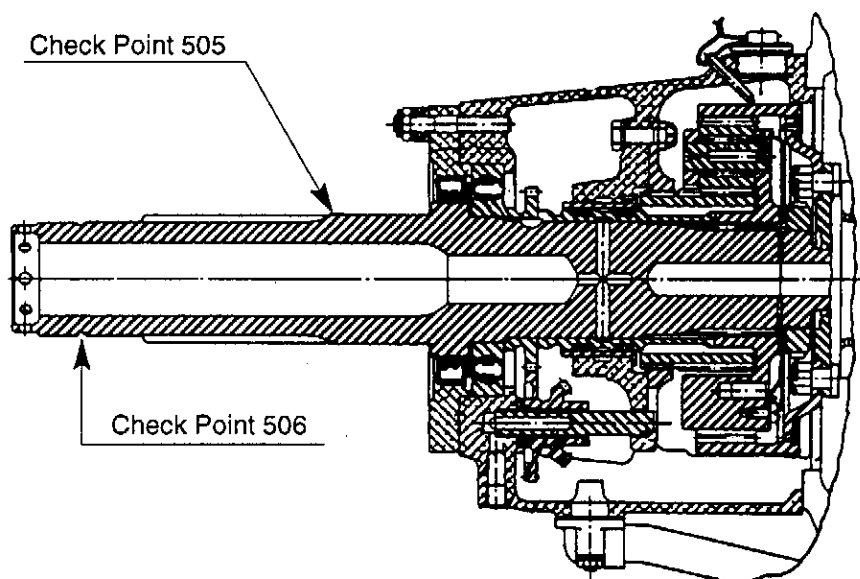
Figure 2.

Measuring of the run true of the forward part of crankshaft shall be performed according to Lycoming Manual Service Table of Limits, see figure 2.
