# SAAB 91 SAFIR SERVICE BULLETIN

Number: 91.1.006

Subject: Inspection of U-profile in main spar of fuselage for corrosion and repair of damages that may be revealed

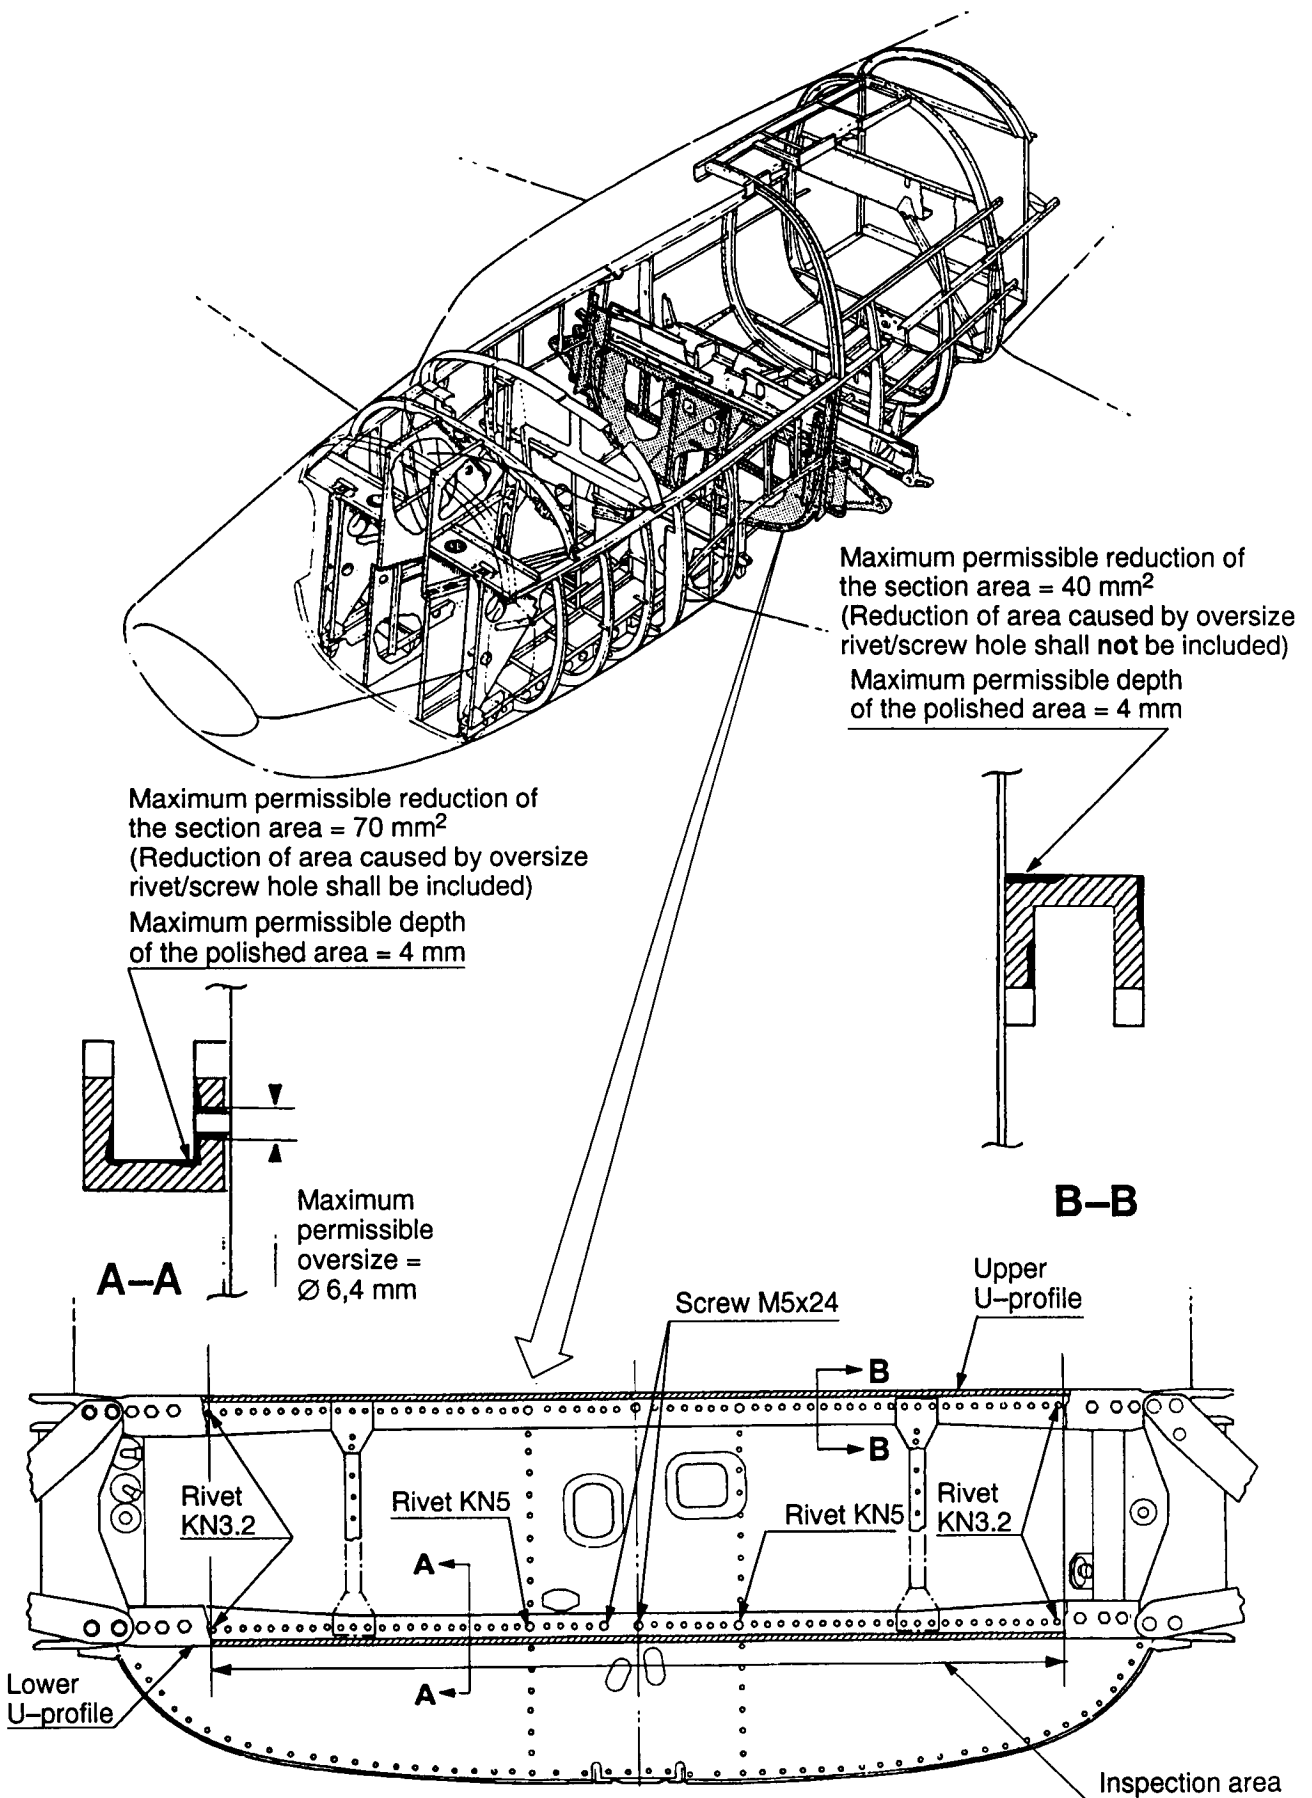
Figure 1. Frame with main spar  
 (Veiv from behind)

Corrosion damages have been revealed in the upper and lower U-profile of the fuselage main spar of the aircraft. The profiles are exposed to heavy stress from the wing loads transferred in the wing coupling brackets attached to the profiles. The corrosion damages may have been caused by grass and dirt being thrown up from the main landing gear wheels and intercepted by the U-profiles of the main spar. The grass and dirt also may cause that the drain holes of the lower U-profile will be plugged up and there will be a risk of corrosion due to undrained moisture. In acidiferous environment this risk will increase. See figure 1.

Inspect the upper and lower U-profile of the main spar for corrosion damages through the LH and RH main landing gear wheel wells, see figure 1.

- 1 Clean the upper and lower U-profile of the main spar by brush or cloth moistured in cleaning solvent. Wipe dry with clean cloth or dry air.
- 2 Visually inspect the affected area by using inspection mirror and bright light, see figure 1.
- 3 Remove eventually damaged protective plating with a clean cloth moistured in thinner and repeat the inspection.
- 4 If there are no corrosion damages, restore the corrosion protection by brusching with alodine 1200 S. Apply then primer and paint.

- 1 Remove the rivets (KN 3,2, KN 5,0) at the corroded area by drilling. Use 3,0/4,8 mm drill and 3,0/4,0 mm punch. See figure 1.  
If necessary remove the screws (M5x24). Se figure 1.  
Access to the spar is gained by removing the front seat buckets. Then fold up the insulating cover to make the row of rivets free.
