MODIFICATION BULLETIN

AIRPL
MODEL
91
Safir

91.6/7

Exhaust Manifold. Lengthening and sealing.

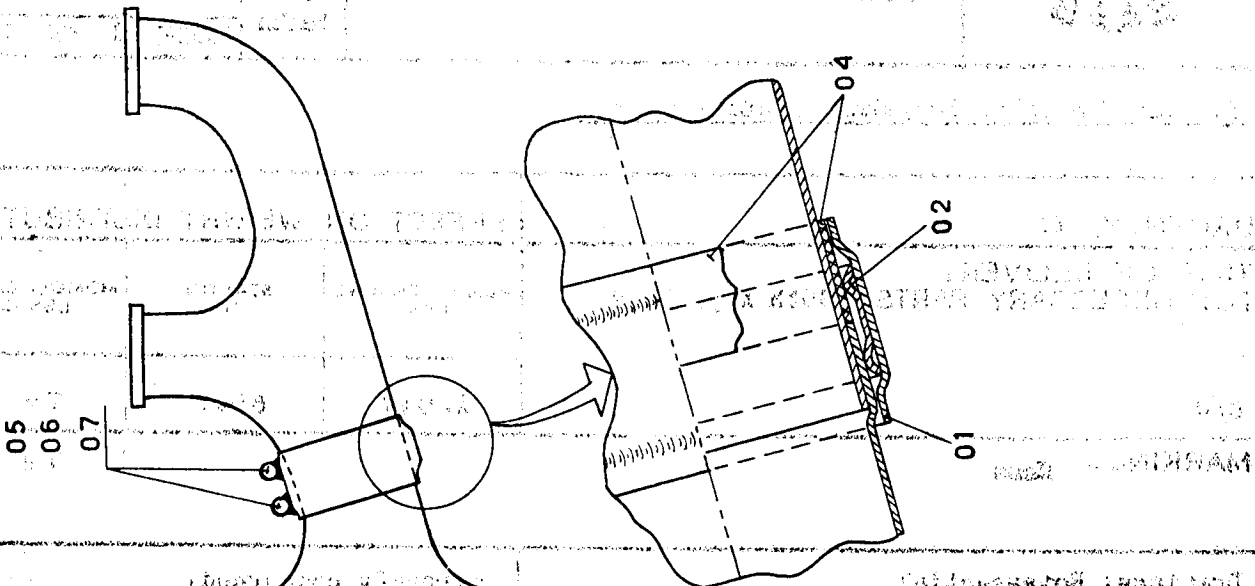
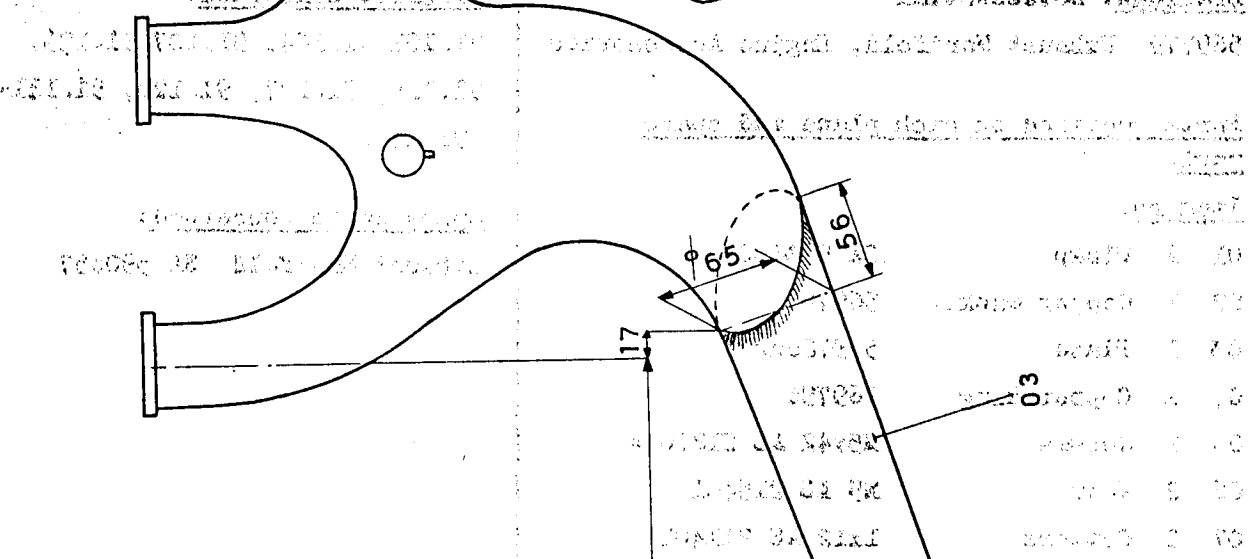
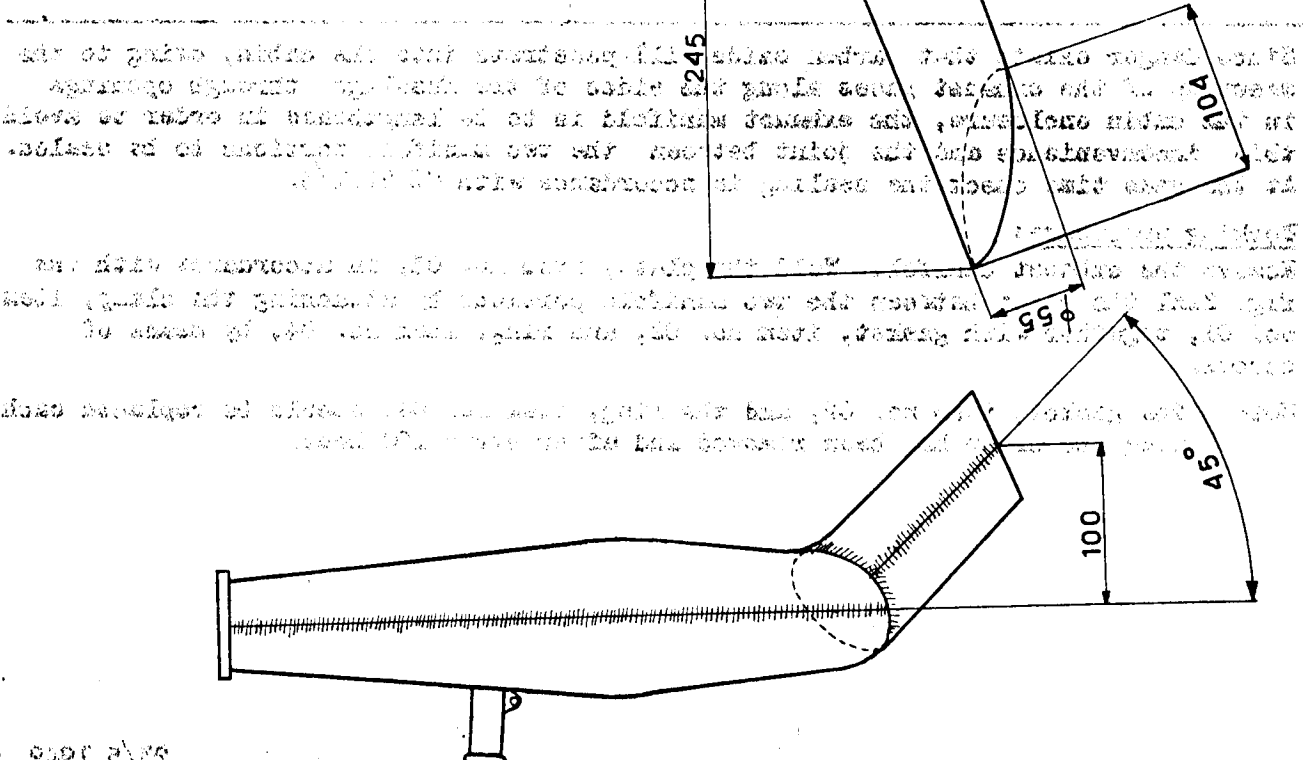
Since danger exists that carbon oxide will penetrate into the cabin, owing to the sweep-up of the exhaust gases along the sides of the fuselage, through openings in the cabin enclosure, the exhaust manifold is to be lengthened in order to avoid this inconvenience and the joint between the two manifold portions to be sealed. At the same time check the sealing in accordance with MB 91.1/5.

Remove the exhaust manifold. Weld the plate, item no. 03, in accordance with the fig. Seal the joint between the two manifold portions by attaching the clamp, item no. 01, together with gasket, item no. 02, and ring, item no. 04, by means of screws.

Note: The gasket, item no. 02, and the ring, item no. 04, should be replaced each time the clamp has been removed and after every 100 hour.
