# service bulletin

No. 91.6.007

AIRCRAFT SAAB SAFIR 91B, 91B-2 AND 91C

**SUBJECT:** Carbureter Marvel-Schebler MA 4-5.

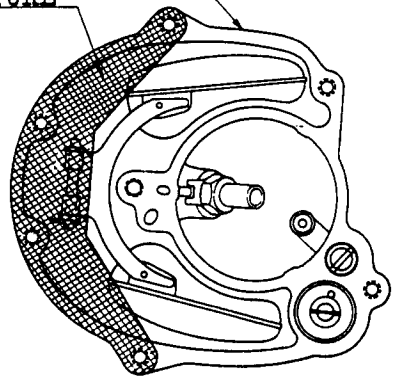
Figure 1

Assemble float and lever assembly to fixture according to fig. 1, using float lever shaft. Screw the fixture to fuel bowl using 4 screws according to fig. 2. By moving the floats up and down when holding the bowl in different positions any contact of floats with the walls of fuel bowl can be detected. If contact is detected, the float lever must be adjusted to obtain at least 1 mm clearance between floats and fuel bowl.
