Modification Bulletin

Reference <u>A/C Saab Safir 91A, 91B, 91B-2, 91C and 91D</u> Improved fastening of the rudder trim-weight.	Date 3.4.70 Saab Service Dept. <i>GF</i> G Funquist Saab Design. Dept. <i>Su</i> S Lundgren	No. 91.3/5
Urgency Class II, within 50 flyinghours	Royal Swedish Board of Civil Aviation for G Antvik <i>AB</i>

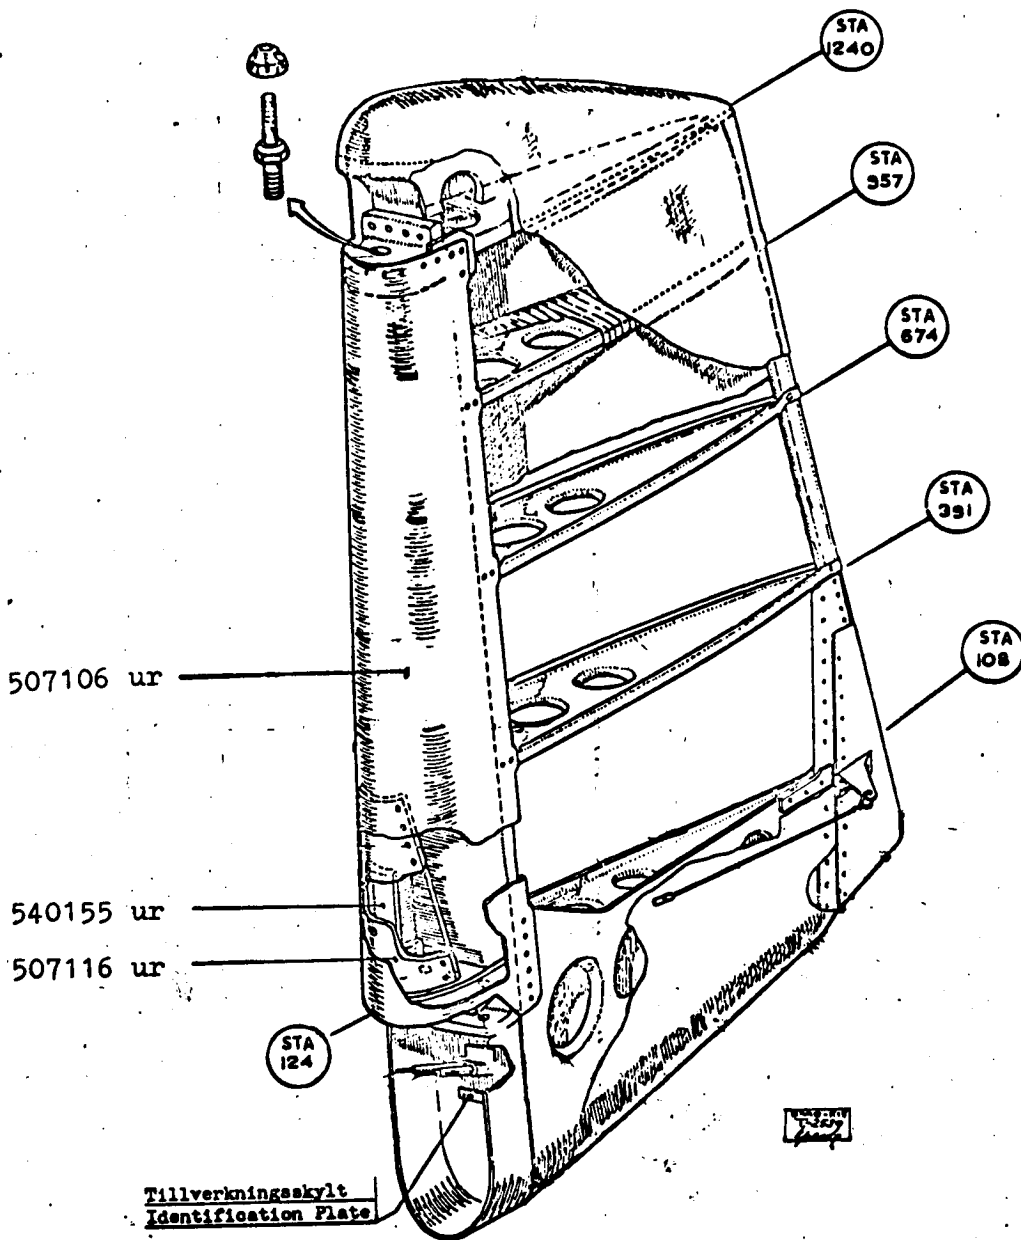
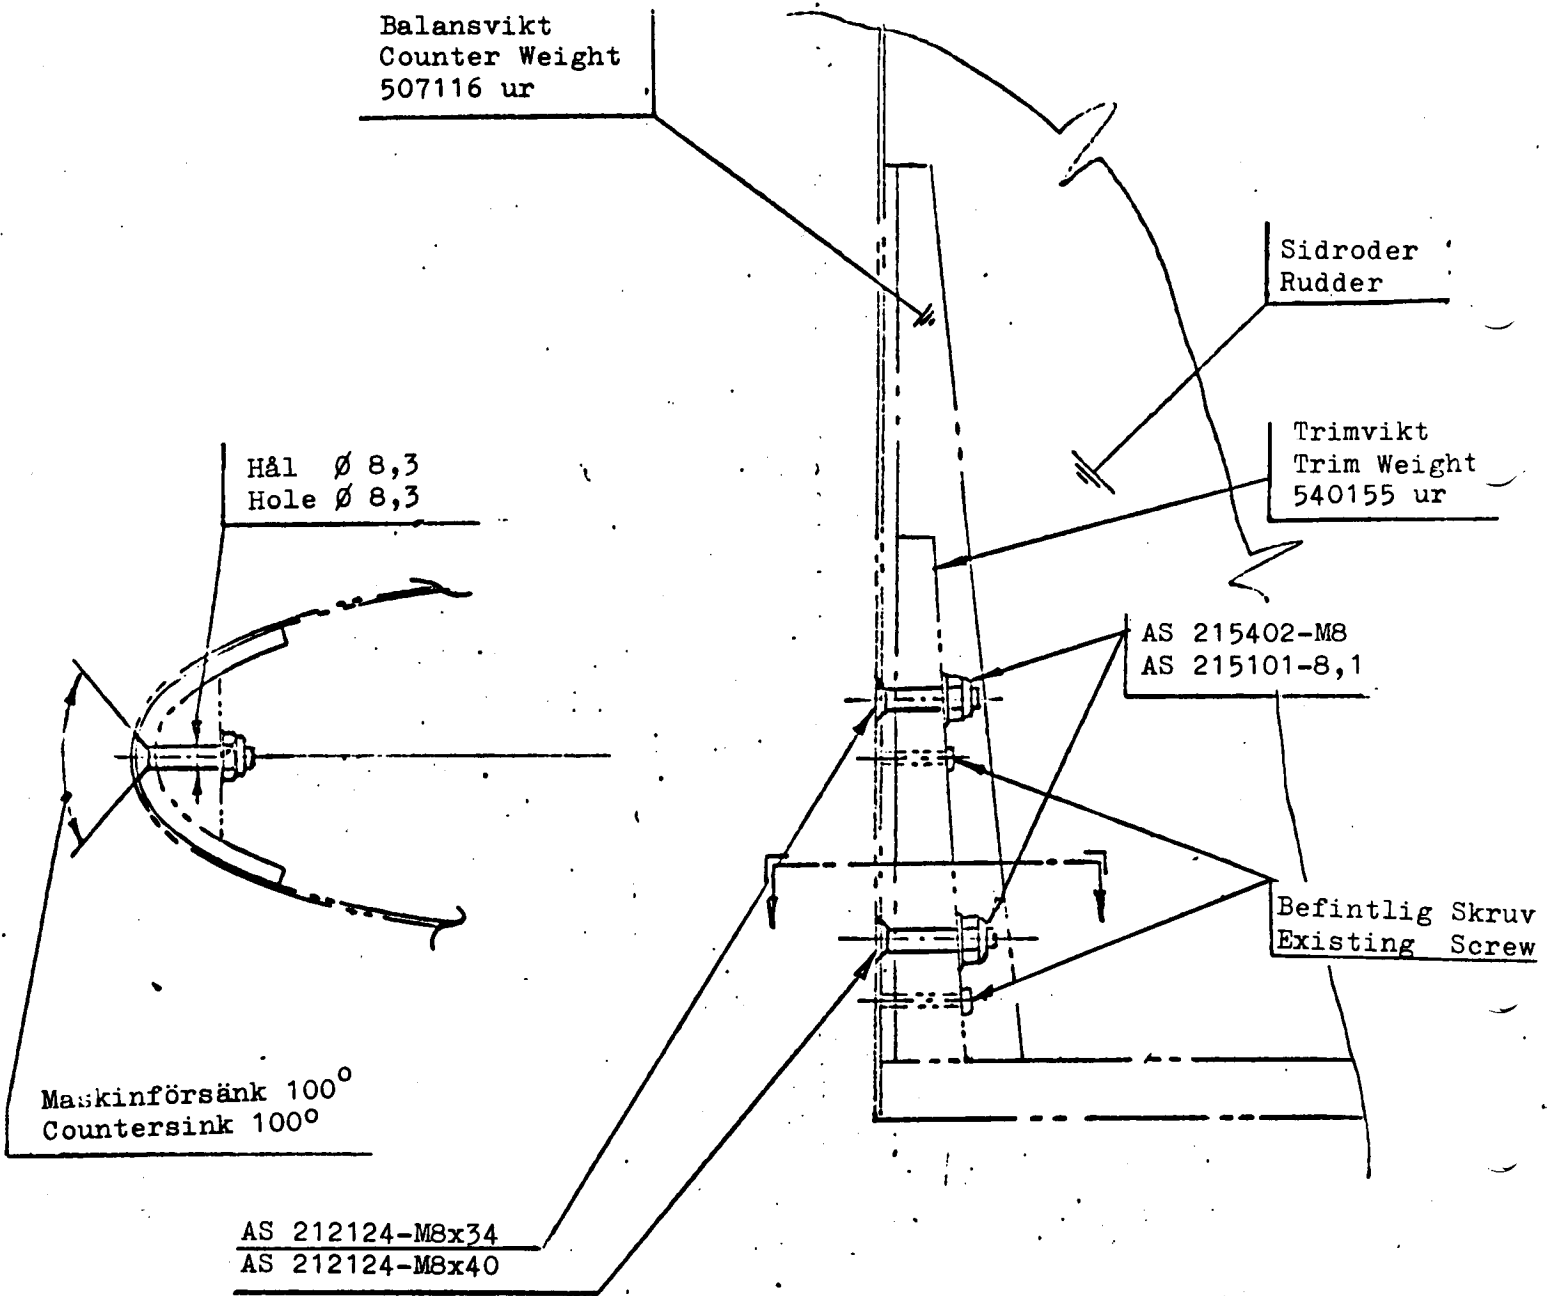
Bil 1
App 1

SIDRODER

RUDDER

- 1 Dismount the rudder
- 2 Check the distance between the bottom rib at STA 124 (appendix 2) and the two attachment screws of the trimweight. Measuring is carried out through the opening in the bottom rib.
- 3 Mark the position of the new screws on the leading edge of the rudder in such a way that the screws will be positioned approx. 20 mm (7/8") above the existing screws.
- 4 Alternative 1 (facing cutter required)

Holes for the facing cutter shaft have to be drilled perpendicular to the rudder leading edge through the skin 507106, balance weight 507116 and trim weight 540155. (Appendix 1). The trim weight rear surface has to be milled for washer AS 215101-8,1.
 The dimension of the holes is increased to 8,3 mm by drilling.

5 Countersink 100° in the balance weight 507116 in the leading edge of the rudder for AS 212124-M8. (Appendix 2).
